FAILURES AND MISCONCEPTIONS

- **AIM OF THE TALK**

- DESCRIBE FAILURES
- SHOW THEIR ORIGIN (MISCONCEPTIONS)
- DETERMINE WHAT WAS WRONG
- DRAW ATTENTION ON BEHAVIOR/PROCEDURES LEADING TO FAILURE

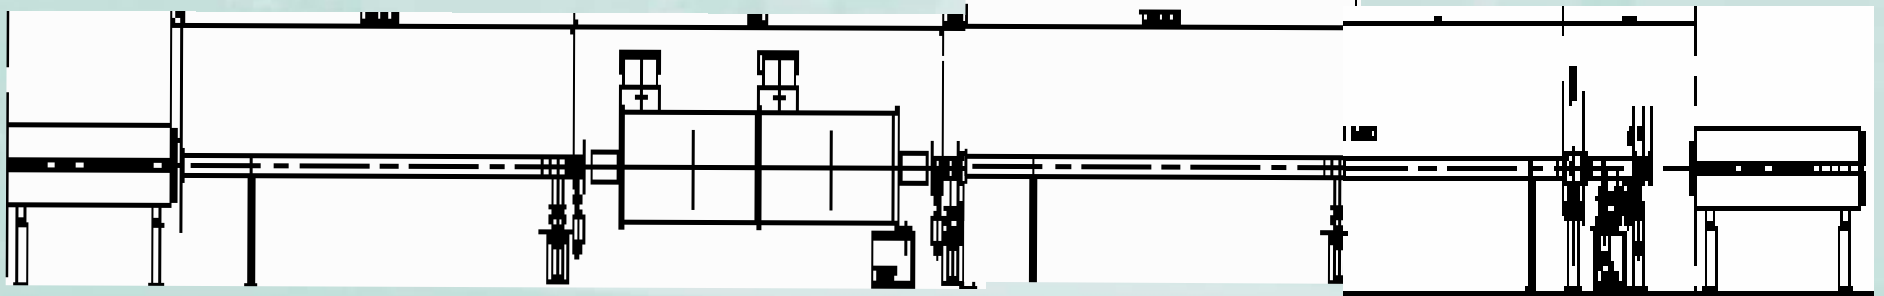
- *0 mn VACUUM ALARM: ION PUMPS SWITCHED OFF AND SECTOR VALVES CLOSED*
- *12 mn LATER: CRYO ALARM: COMPRESSOR STOPPED*
- *35 mn :ALARM LOW He IN CAVITY*
- *39 mn : VACUUM ALARM SECTOR VALVES CLOSED AROUND CAVITY*

- *AFTER COOL DOWN CAVITY HAS LOST RESONANCE!*
- *RECOVERED AFTER COMPLETE WARM UP AND RECOOLING (CONDENSED GAS THICKNESS)*

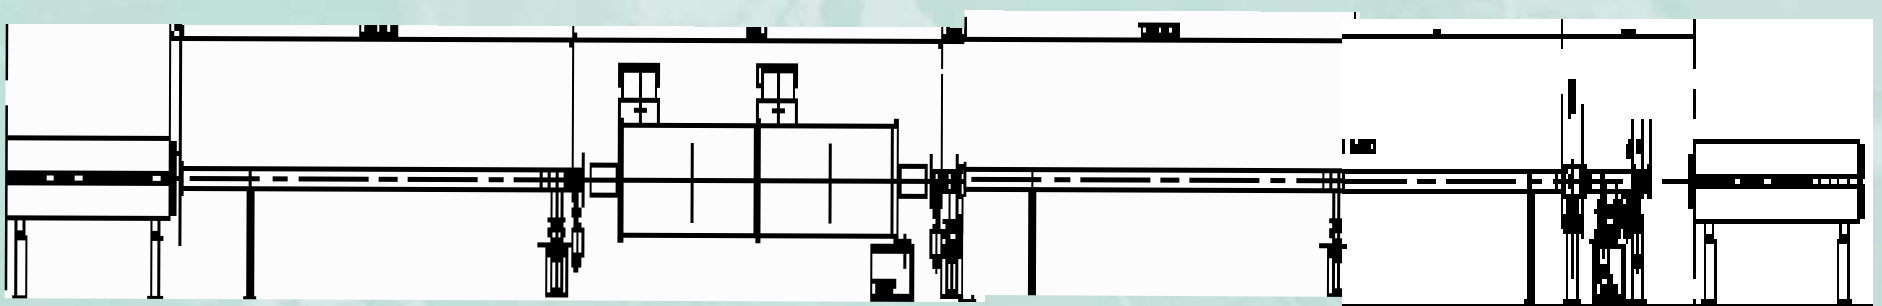
- *THE PROTON BEAM MADE A HOLE IN THE VACUUM CHAMBER*
 - *SOME VALVES CLOSED, NOT THOSE BETWEEN THE HOLE AND THE CAVITY (NEEDS 3 BAD ION PUMP SIGNALS)*
 - *FINALLY WHEN THE LIQUID HELIUM LEVEL WAS LOST THE SECTOR VALVES AFTER THE CAVITY CLOSED AND AVOIDED FURTHER PROPAGATION*

- *FOR HISTORICAL REASONS INTERLOCKS WERE SET AT MAXIMUM (P.P., 80^{IES}), A 3S DELAY WAS INTRODUCED TO ELIMINATE FALSE TRIGGERS*
 - *AGING POWER SUPPLIES :
NO MORE ABLE TO DELIVER FULL CURRENT =>
=> INTERLOCK LEVEL NO MORE REACHABLE*
 - *FAST VALVES WERE OPENED DESPITE BAD PRESSURE*

- *INTERLOCK LEVELS DEPENDS ON THE OPERATION CONDITIONS*
- *THEY MUST BE PERIODICALLY REVIEWED AND KEPT TO A MINIMUM COMPATIBLE WITH SAFE OPERATION*
- *TOO MANY INTERLOCKS => BY-PASS*
- *A BY-PASSED INTERLOCK IS MORE DANGEROUS THAN NO INTERLOCK*

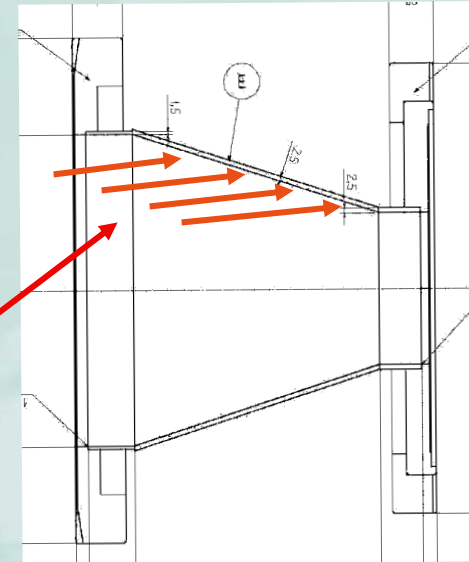
- *FROM 45 GEV (1989) TO 100 GEV (1999)
(i.e. 40->1000 W/m)*
- *SOME COMPONENTS DESIGNED FOR 45 GEV
FORGOTTEN
(UNCOOLED TRANSITIONS ELLIPTICAL->
CIRCULAR)*
- *INAPPROPRIATE FOR USE ABOVE 90 GEV
(SYNCHROTRON LIGHT POWER)*
- *MANY FAILURES:*
 - OVERHEATED CF GASKETS
 - WELD FAILURES (REPEATED THERMAL CYCLES)

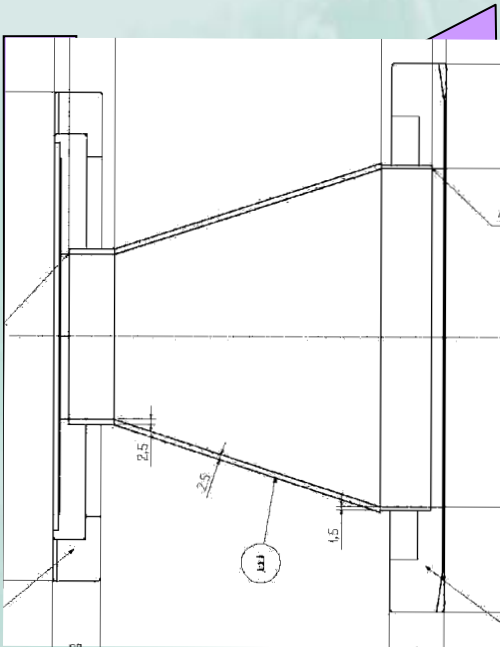
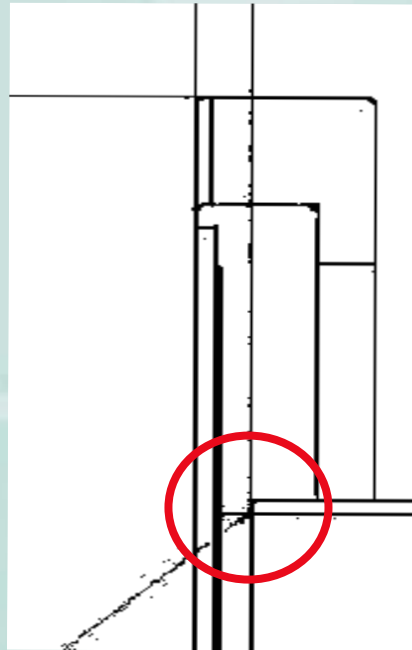
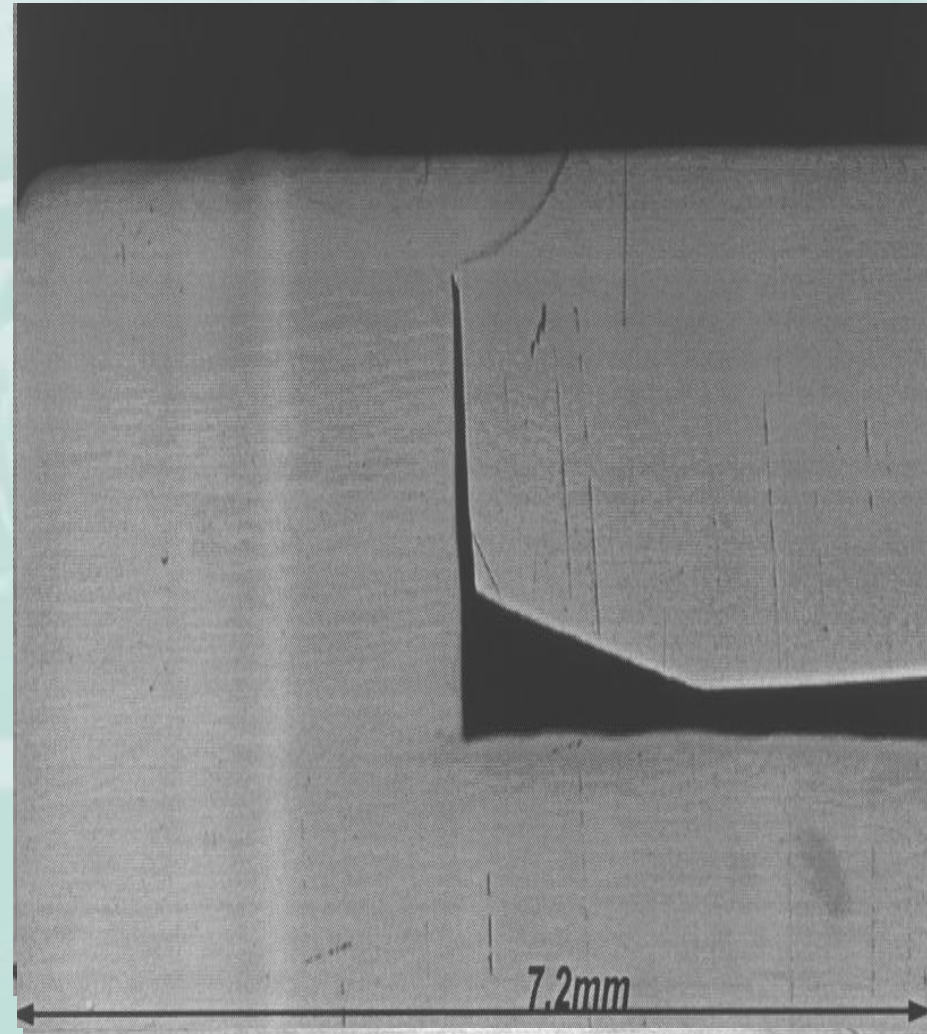
- **THE LEP ENERGY UPGRADE:**
 - **WELD FAILURES:**
 - **CLASSIC WELD**
304 L TUBE / 316 LN FLANGE

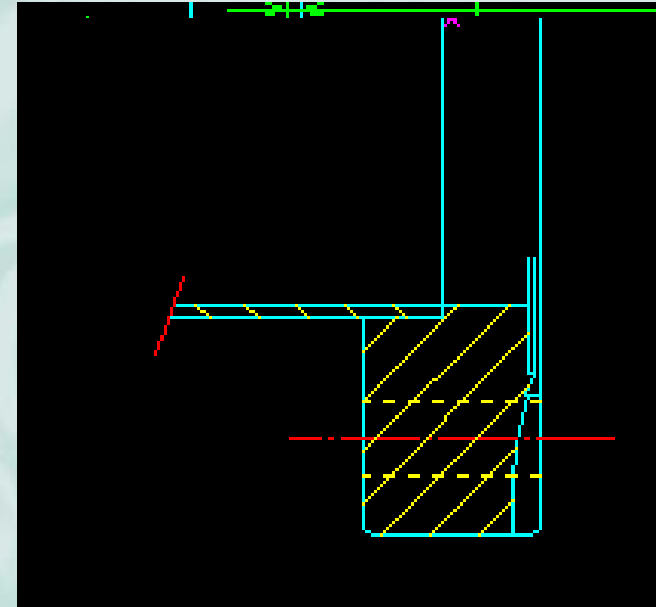
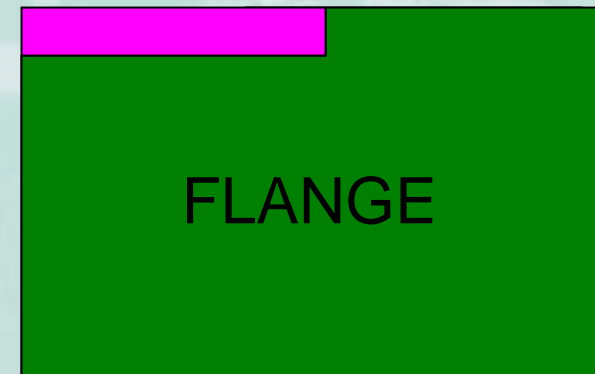
- *FORGOTTEN WEAK ELEMENT*
+
- *IMPROPER WELD PREPARATION:
MASSIVE <-> THIN PIECES*

- *=> LACK OF PENETRATION FOR THE
MASSIVE PART*

- *WELDING LIPS PREFERABLE*

- *PROVISIONAL IS DANGEROUS AND MUST BE TRACED*
- *WELL ORGANISED DATABASE OF COMPONENTS :
=>EASY TO FIND PIECES WITH SIMILAR GEOMETRIES*
- *STANDARDISATION OF ESTABLISHED GOOD PRACTICE/RECEPIES
e.g. FOR WELD GEOMETRY*

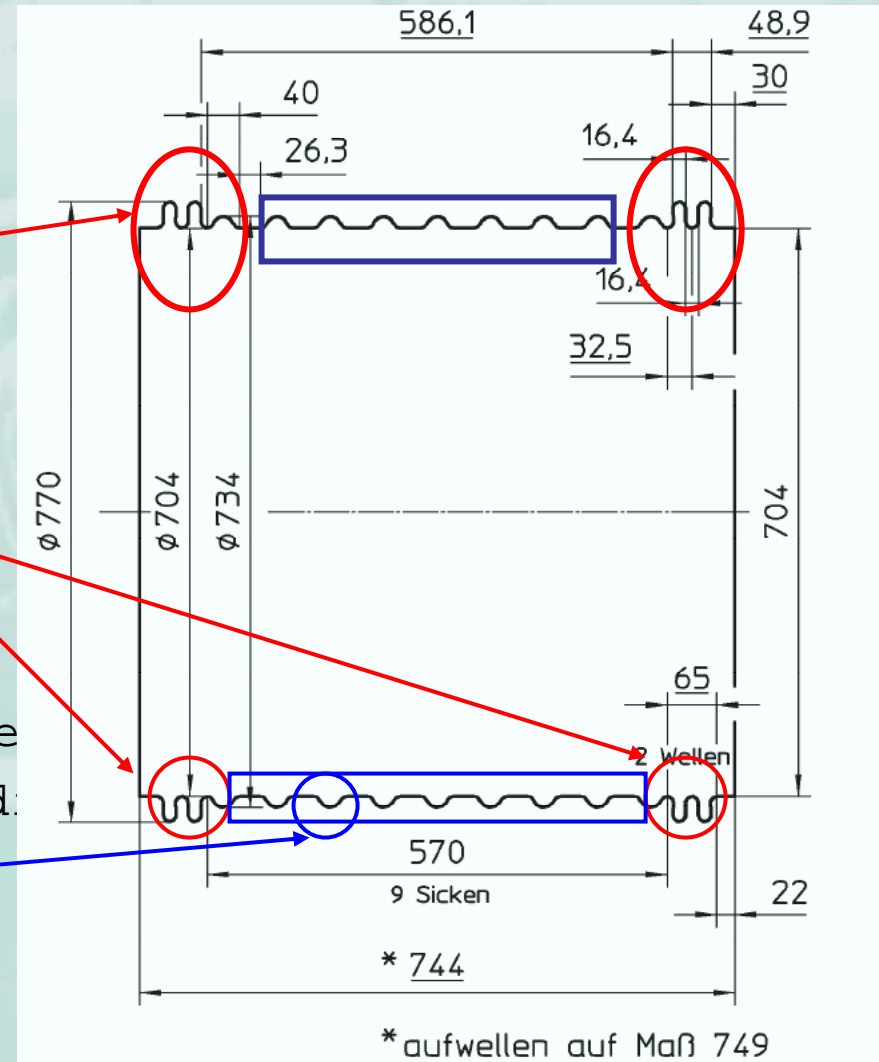
- *Mainly for alignment:*
- => “cardan design”
- *Limited temperature variation*

- *4 large undulations (flexibility)*
- *Rigid spacer*

–For economical reasons:
spacer same material/thickness
=>Undulations needed for rigid.
Nominal height 15mm

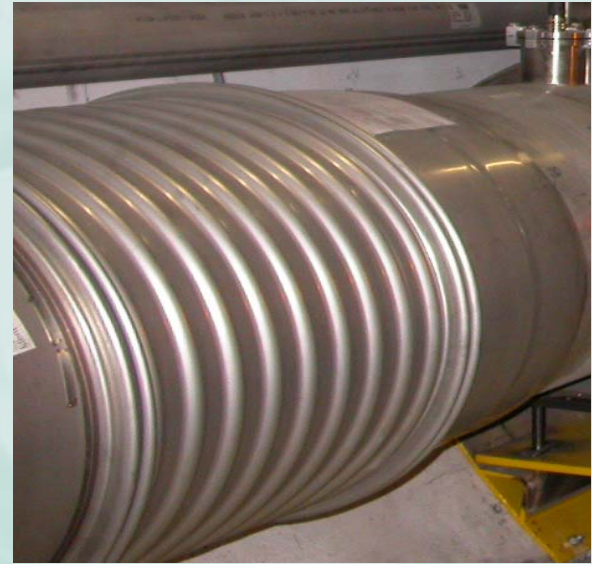
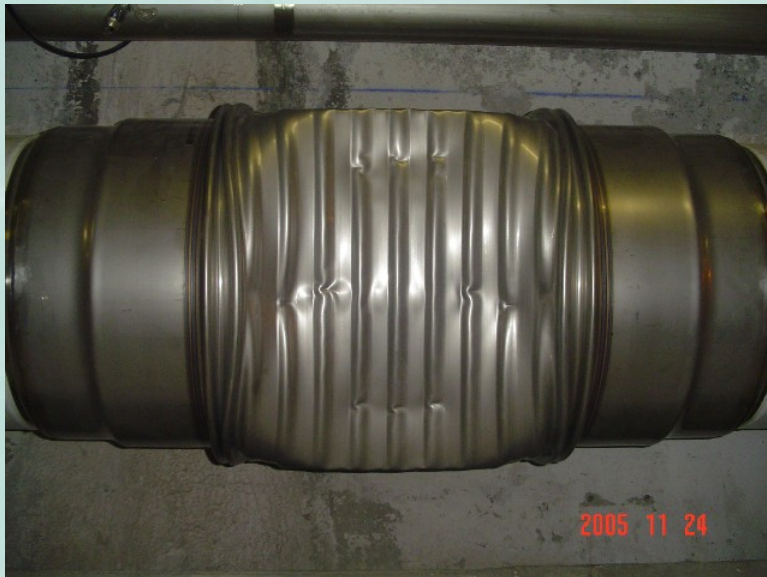
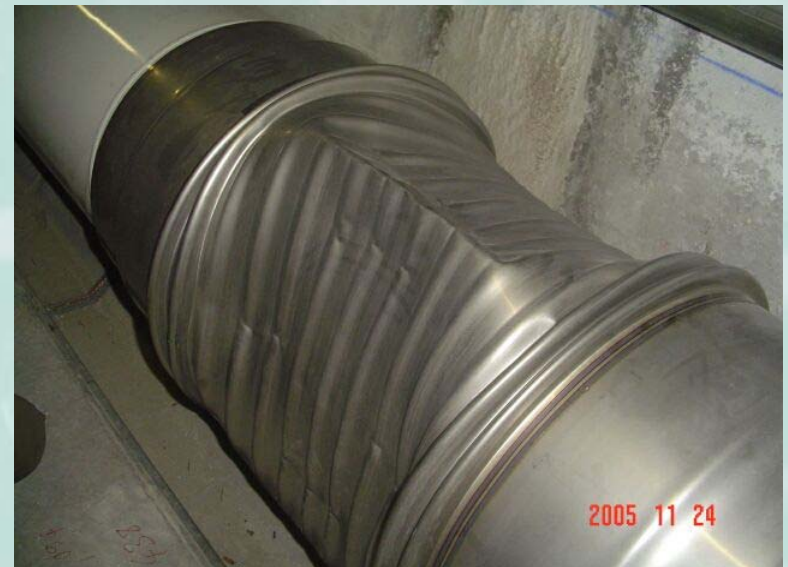
- Initial installation without problem
- Collapses after impacts
- But later without external intervention

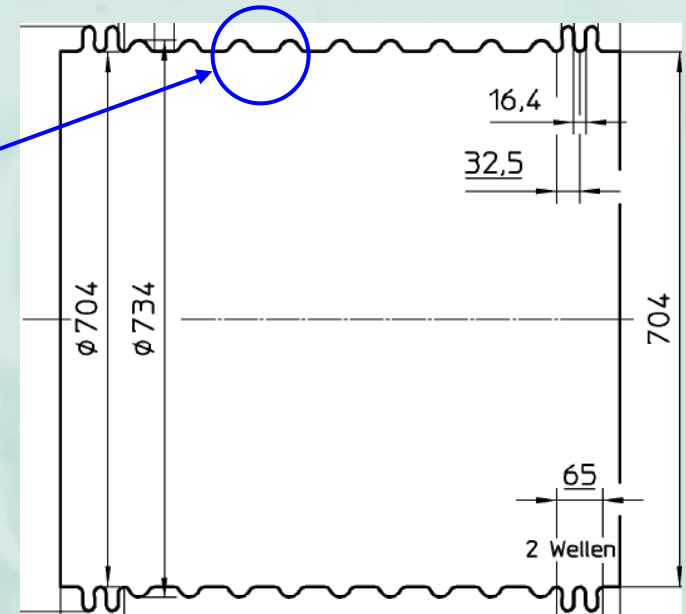
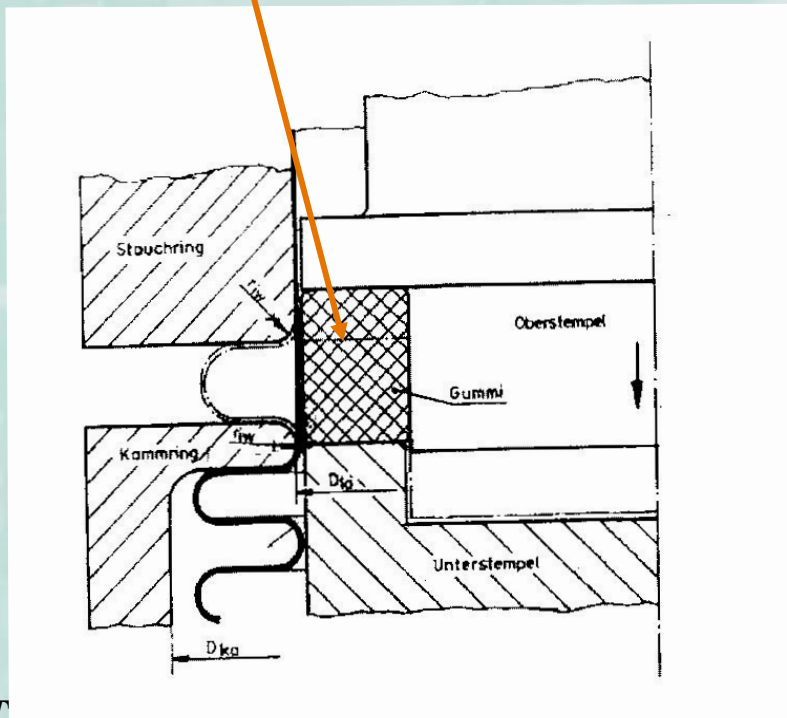
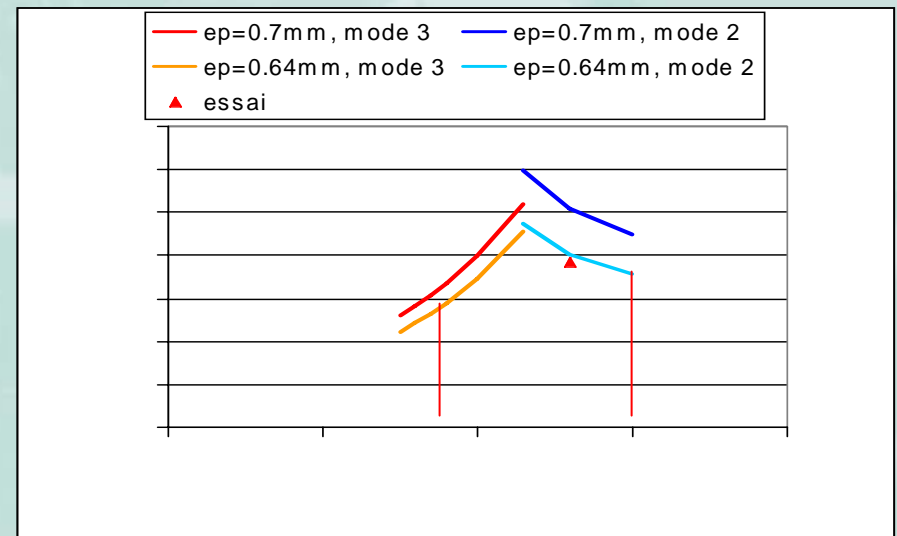
- *NOMINAL 15mm*
- *MEASURED 8 mm*
- *DRIFT DURING THE PRODUCTION (TOOLING)*

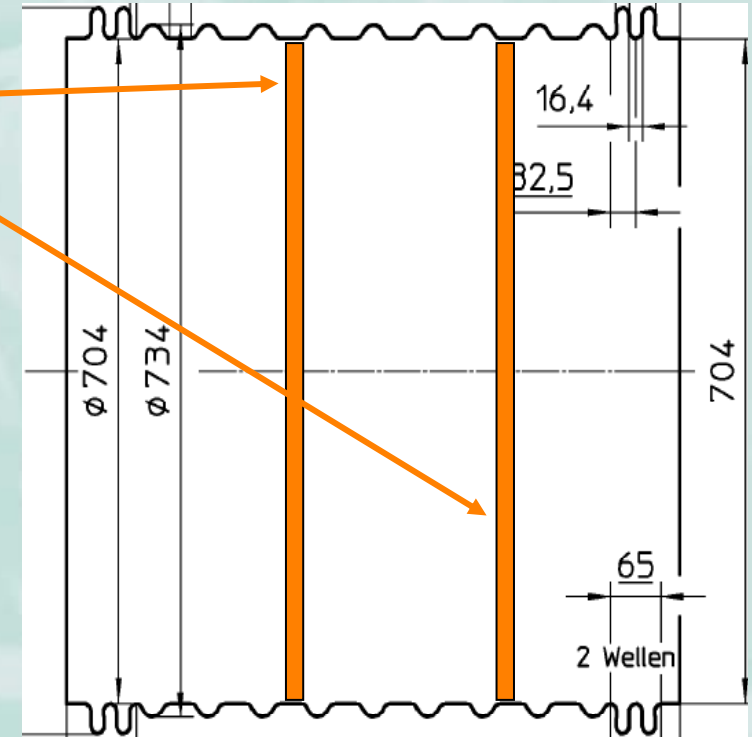
- *INAPPROPRIATE CODE FOR CALCULATIONS (thin walls)*

- *UNMONITORED DRIFT DURING FABRICATION*

- *Note: PRODUCED BY A SUB-CONTRACTOR OF THE MAIN CONTRACTOR*

- 2 REINFORCEMENT RINGS

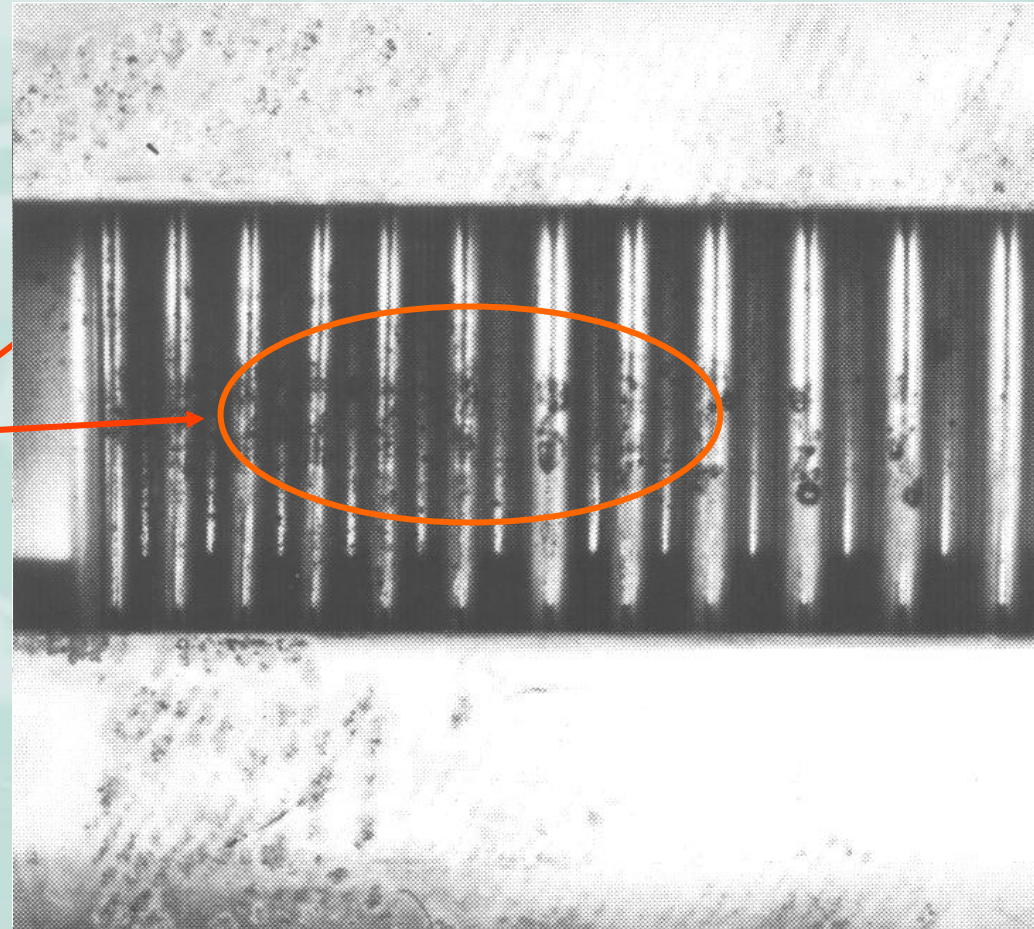
- *LEAK ON A QUAD CHAMBER (BELLOW) INSTALLED FOR 1 YEAR*
- *MATERIAL ST. STEEL 316 L*
- *HEAVY OXIDATION VISIBLE WHERE THE BELLOWS WAS ACCESSIBLE*

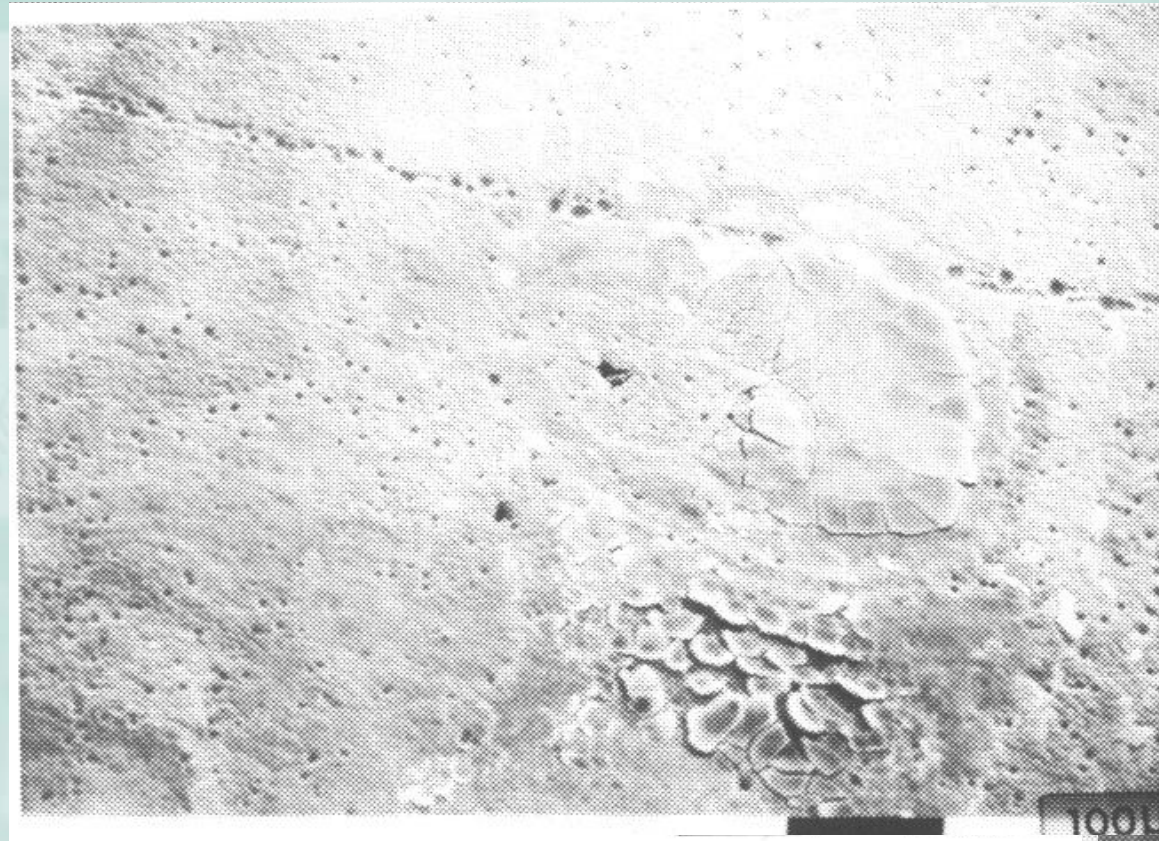
- *LEAK FROM OUTSIDE*

- *AND FROM INSIDE*

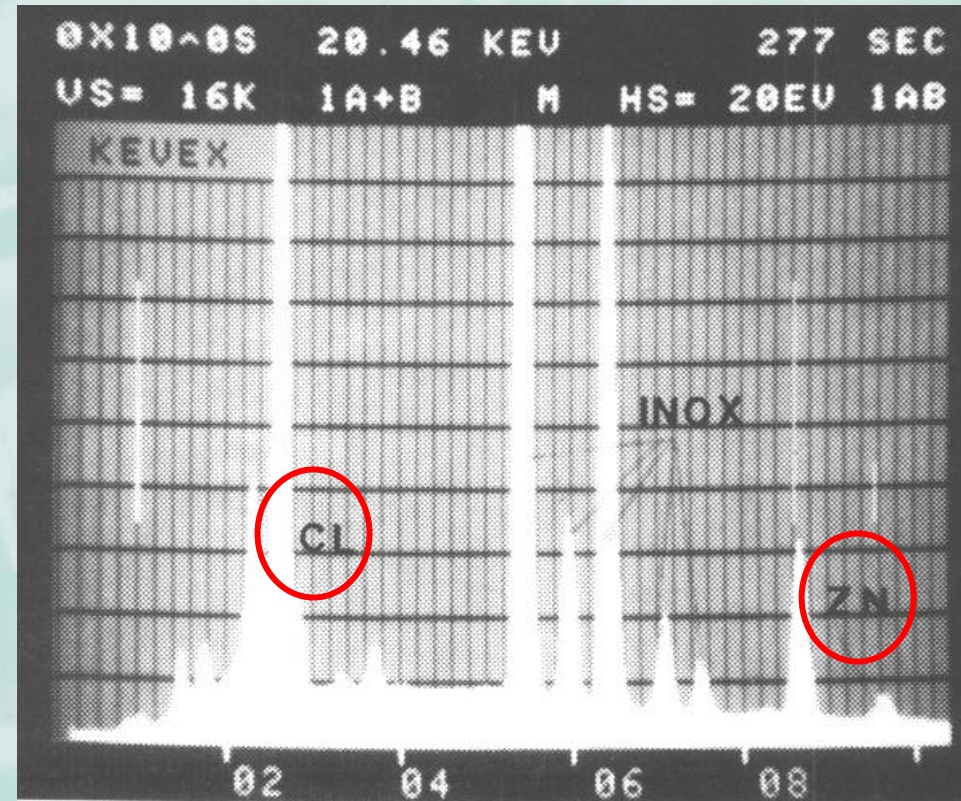
- *CULPRIT HAS LEFT TRACES*
- *CORROSION BY BRAZING FLUX (*ZnCl₂)*
- *ST. STEEL EXTREMELY SENSITIVE TO
Cl PITTING*

**–BRAZING ACTIVITIES WITHOUT PROTECTION
(and care) ON ADJACENT MAGNET**

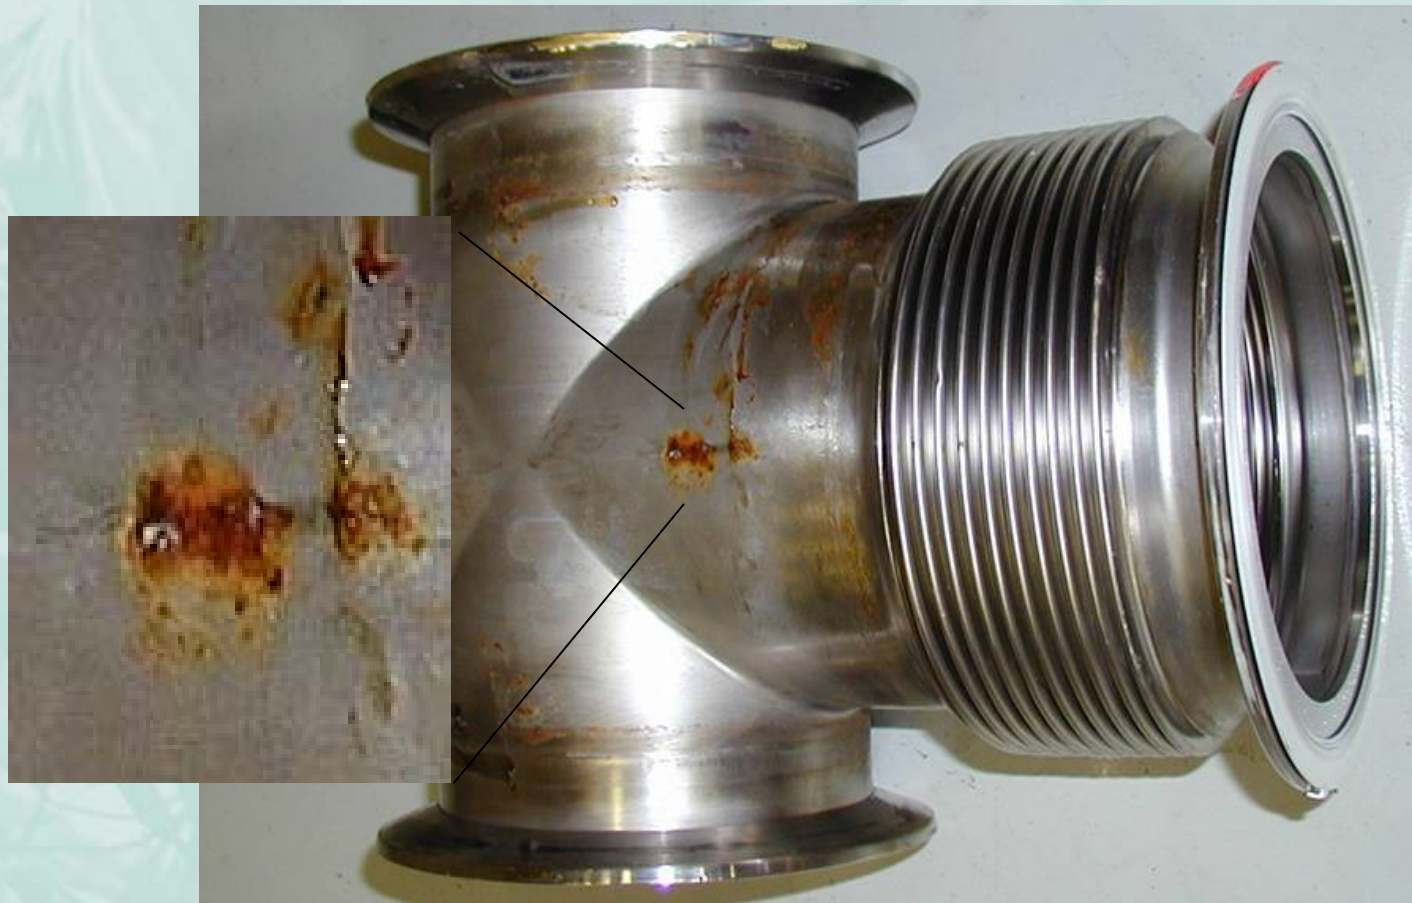
- OTHER EXAMPLES

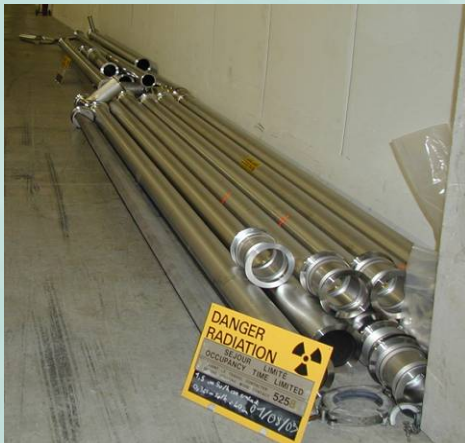
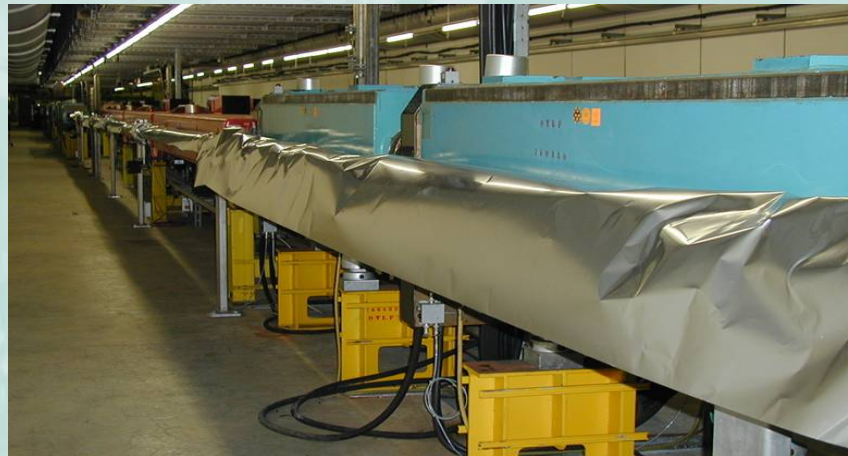
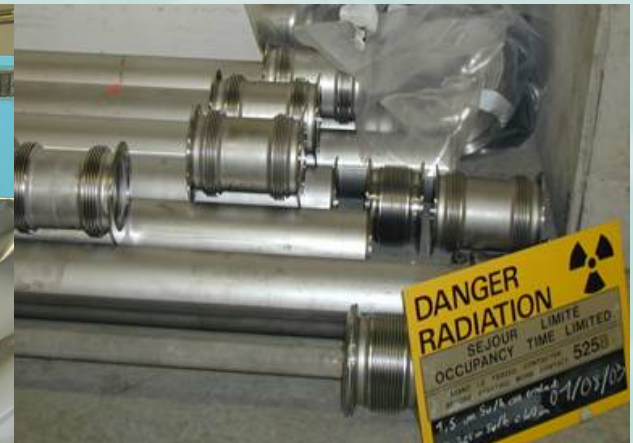
–VERY COSTLY:

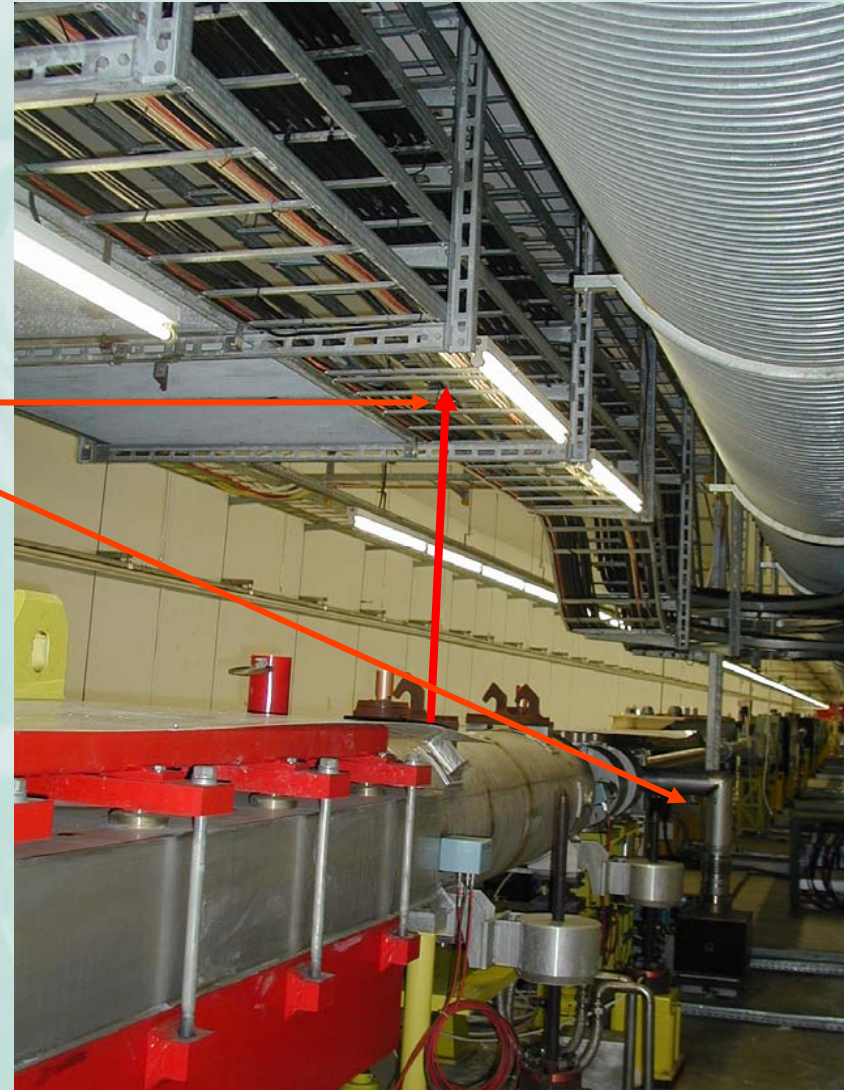
–MOST DAMAGES ON TOP OF COMPONENTS: CABLE TRAY

–NOTE DISCOLORATION!!

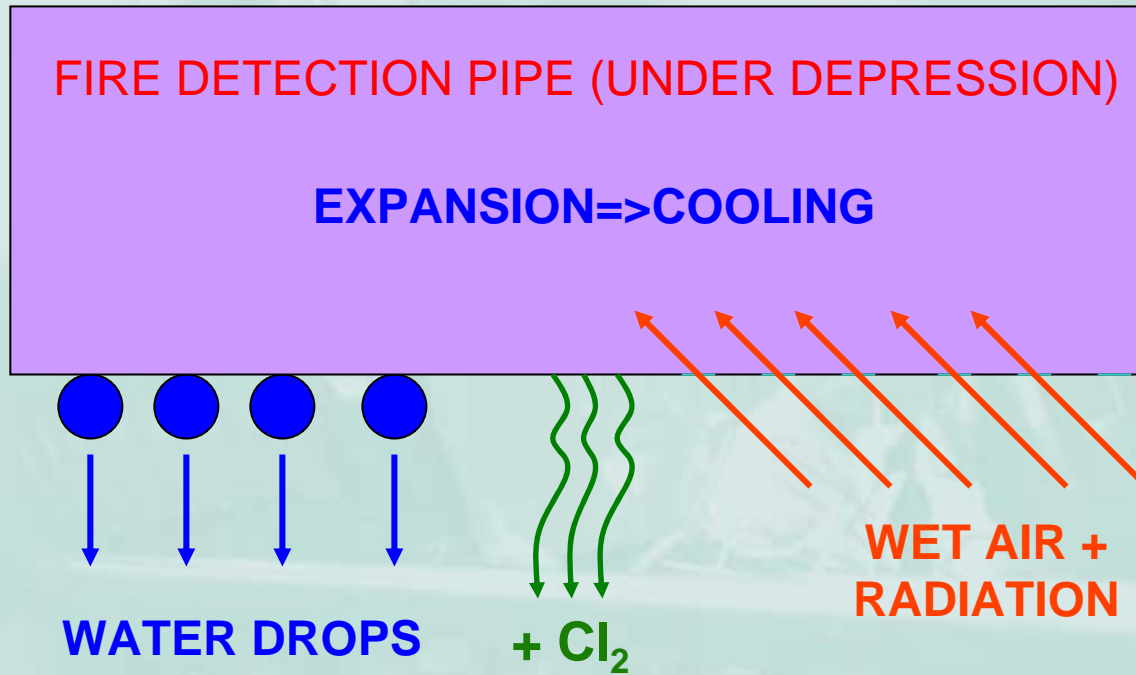
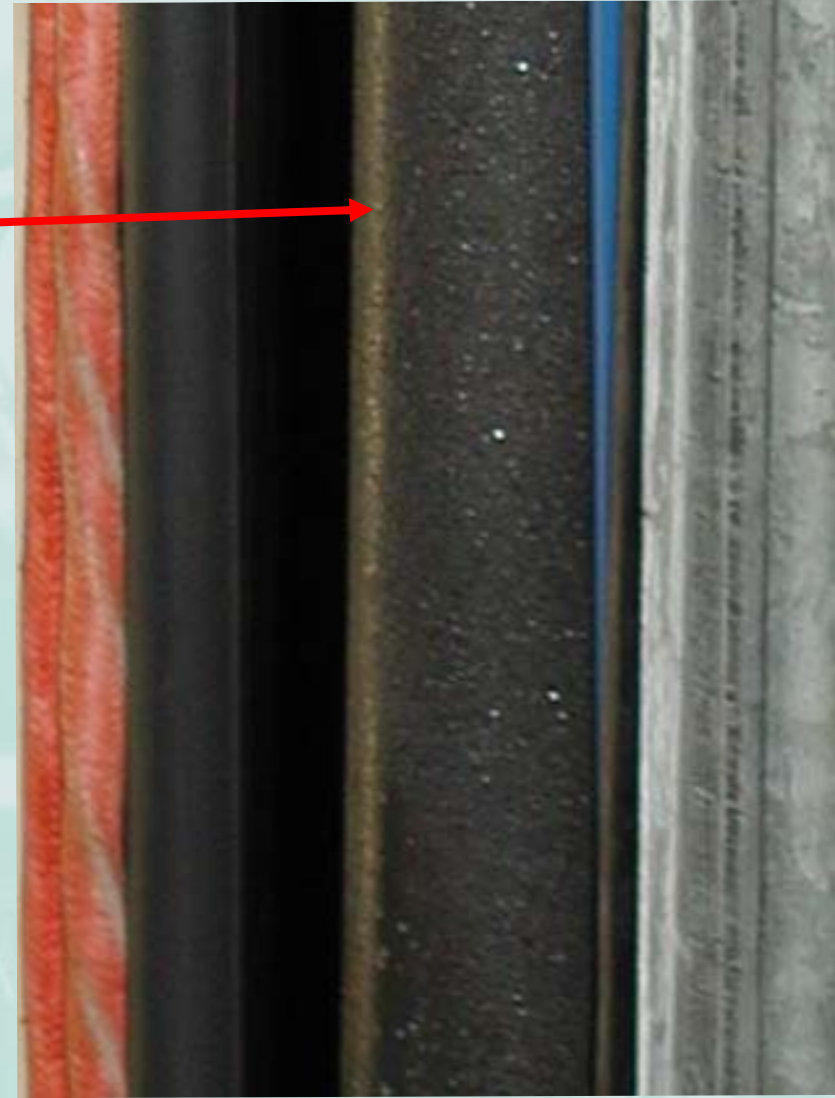
**–THE FIRE DETECTION PIPE
WAS MADE OF PVC!!!**

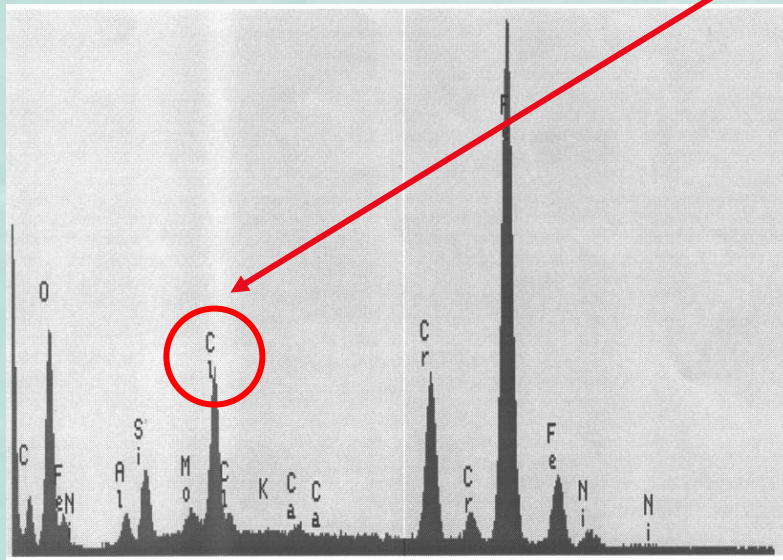
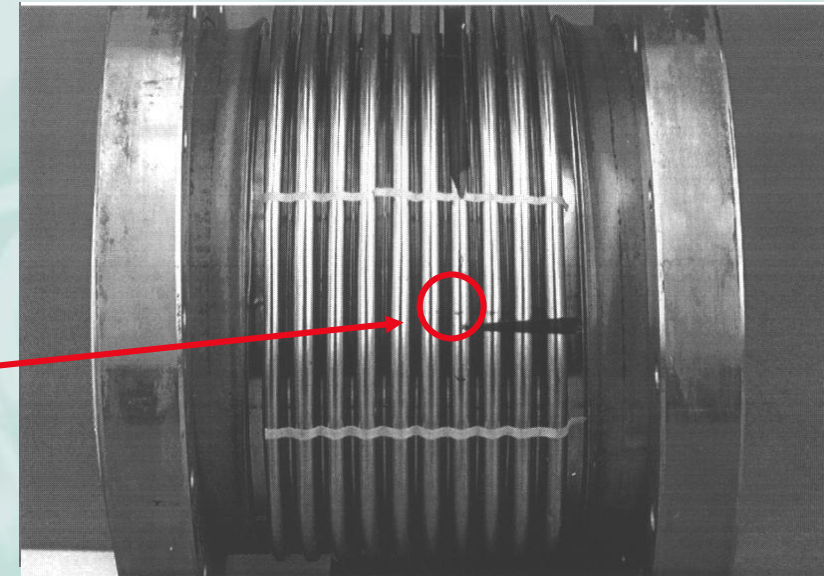
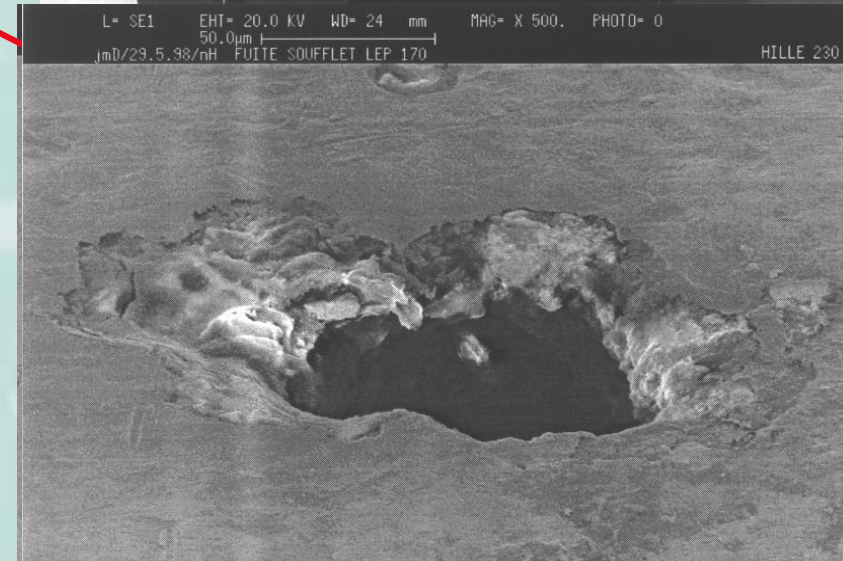
- *A bellows in LEP injection region (high radiation area)*
- *Leak position:*
- *Presence of chlorine*

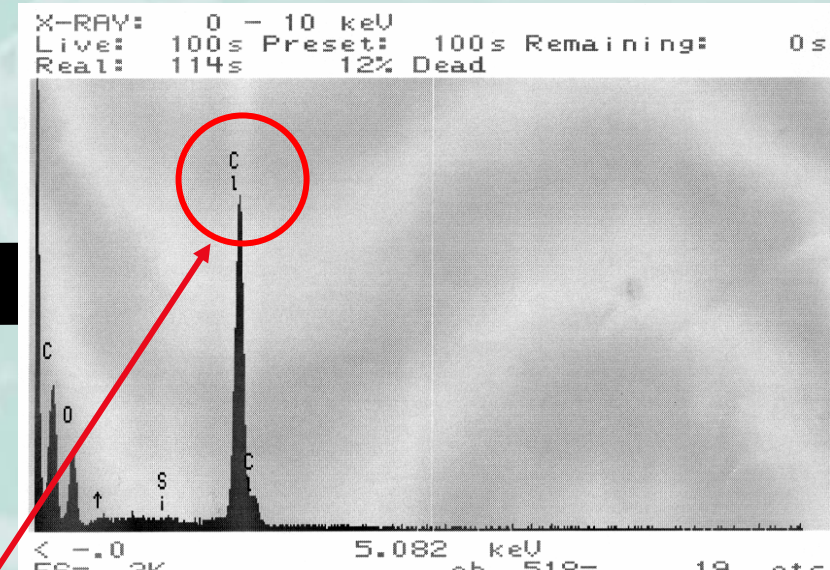
- *SIGNAL NEEDED FOR THE INJECTION TIMING*
- *TRIGGER GIVEN BY A PHOTOMULTIPLIER*
- *TRANSPARENCY \Leftrightarrow MORE SENSITIVITY*
- *=> BELLOWS IDEAL*
- *PHOTOMULTIPLIER AS CLOSE AS POSSIBLE TO THE BEAM*
- *=> TOUCHING THE BELLOW*

- *THE ADHESIVE BLACK TAPE AROUND THE PHOTOMULTIPLIER CONTAINED CHLORINE (PVC BASED)!*
