ElectroMagnetic Interference

Recurrent EMI mistakes - Good & poor practical fixes

Alain CHAROY - (0033) 4 76 49 76 76 - a.charoy@aemc.fr

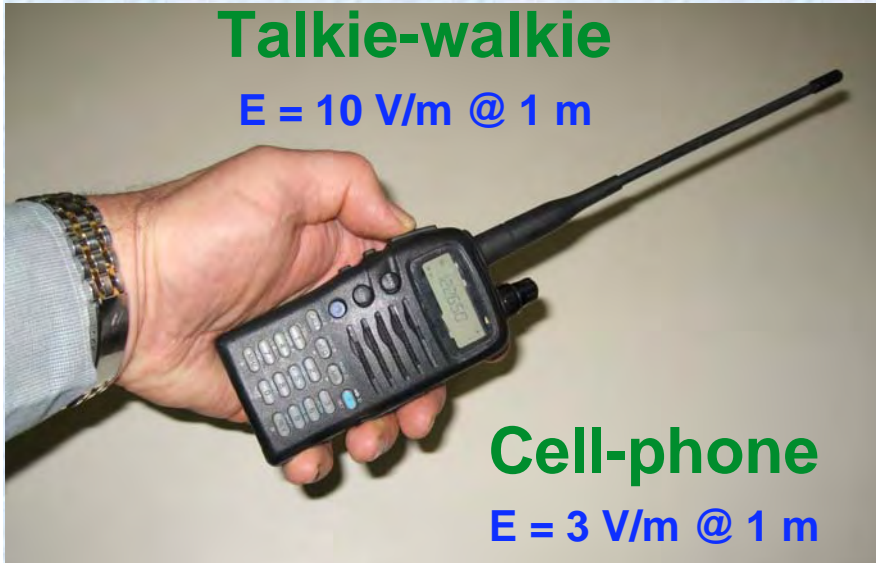
Talkie-walkie

$E = 10 \text{ V/m @ 1 m}$

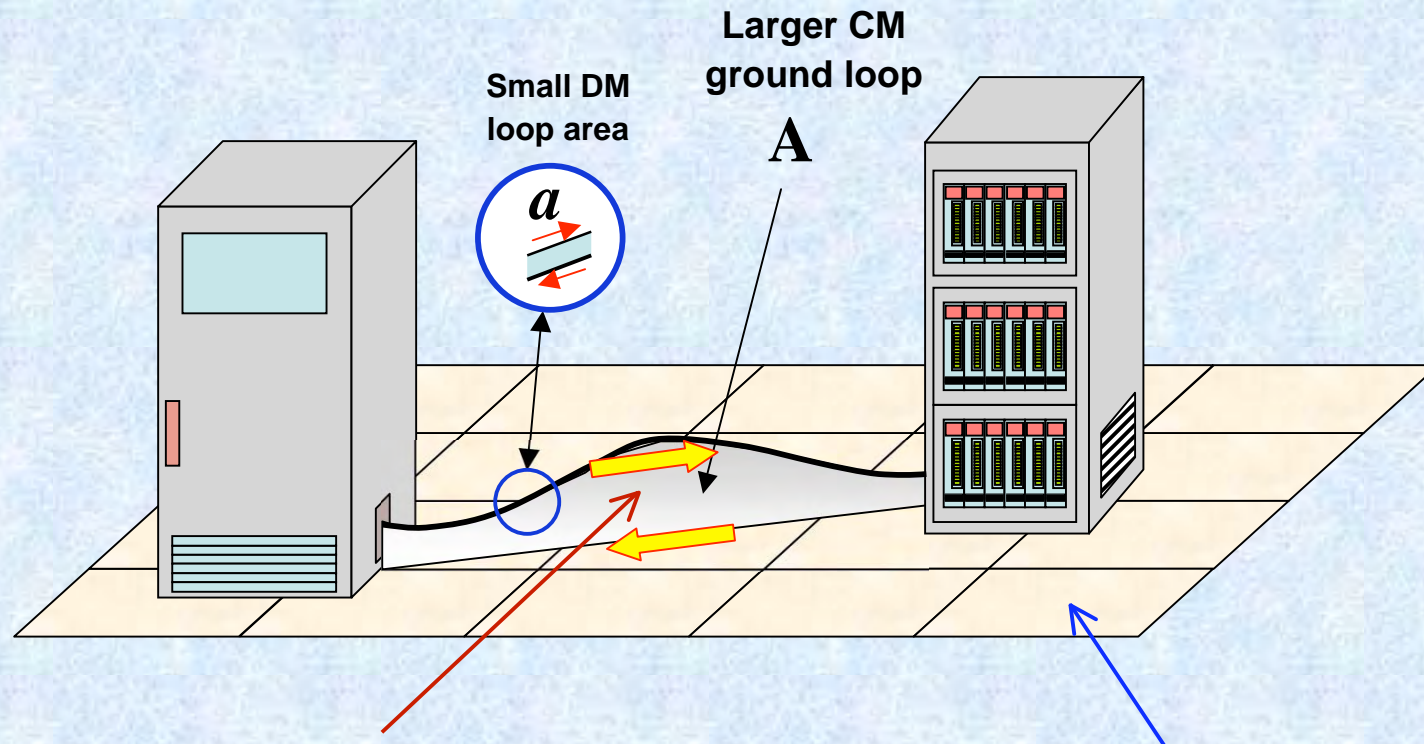
The Ground Loop problem

A variable magnetic field (difficult to shield at LF) induces voltage across loops

This ground loop area is unavoidable

It should be reduced by:

- Laying the cables down over the (metallic) ground plane
- Using cable trays (in contact from one end to the other)
- Using shielded cables with connection at both ends

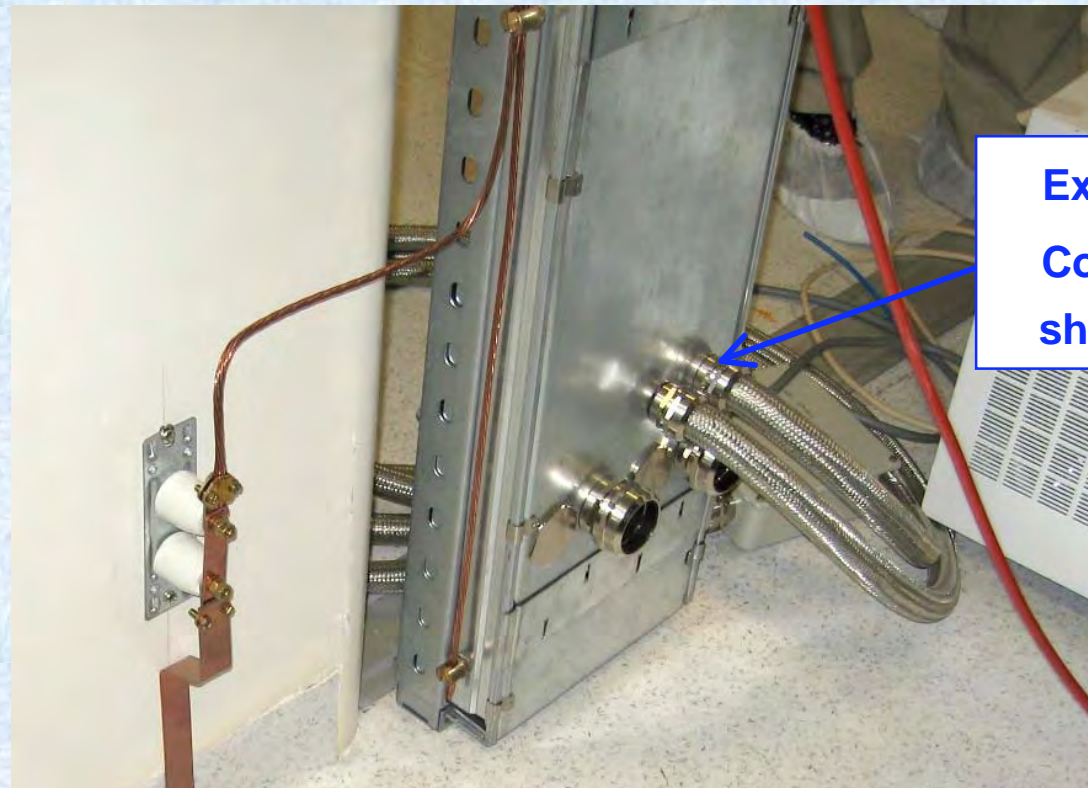
Cable arrangement in a metallic section

**Excellent solution:
Continuous cables
shielding with nuts**

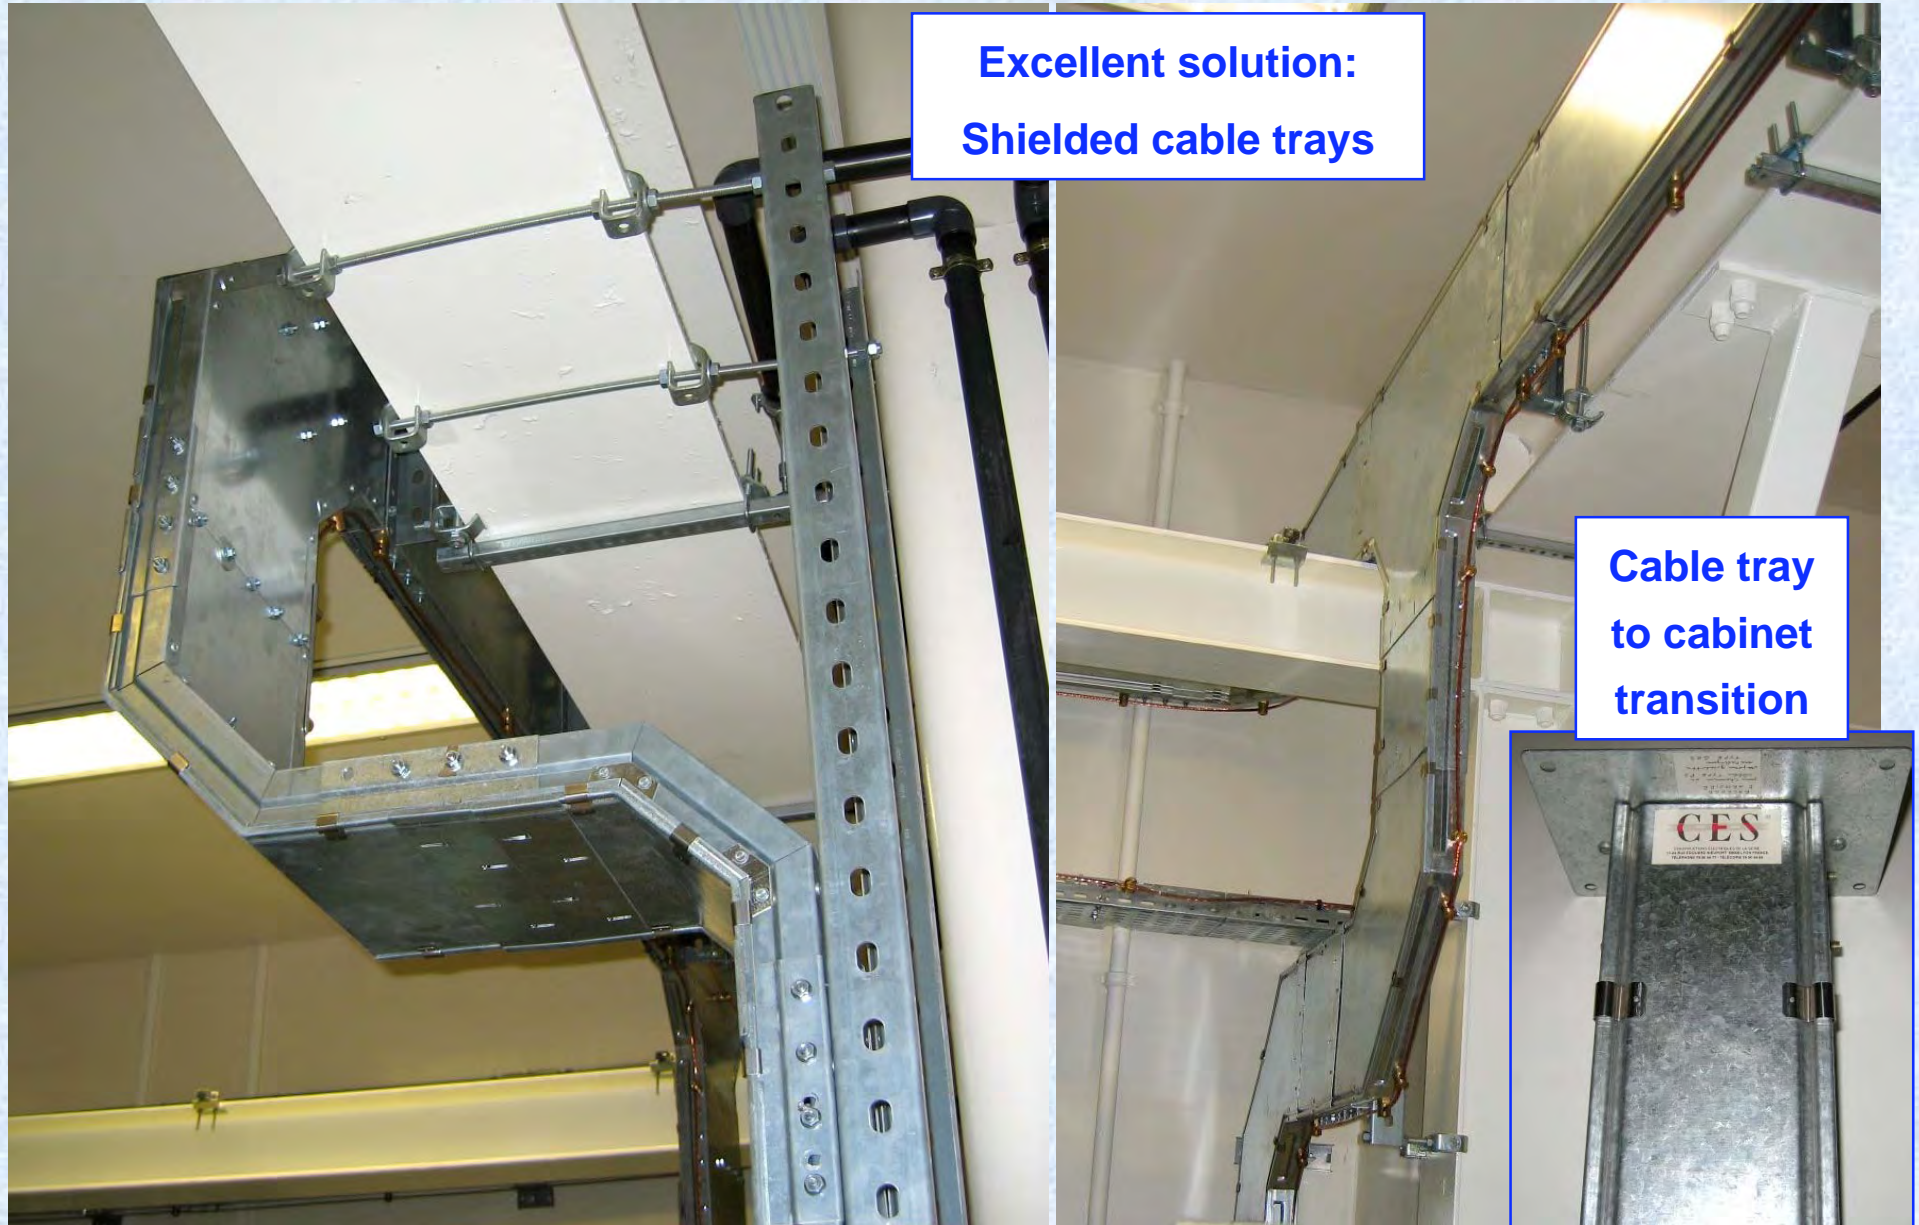
Cable tray to cabinet
transition

Excellent solution:
Shielded cable trays

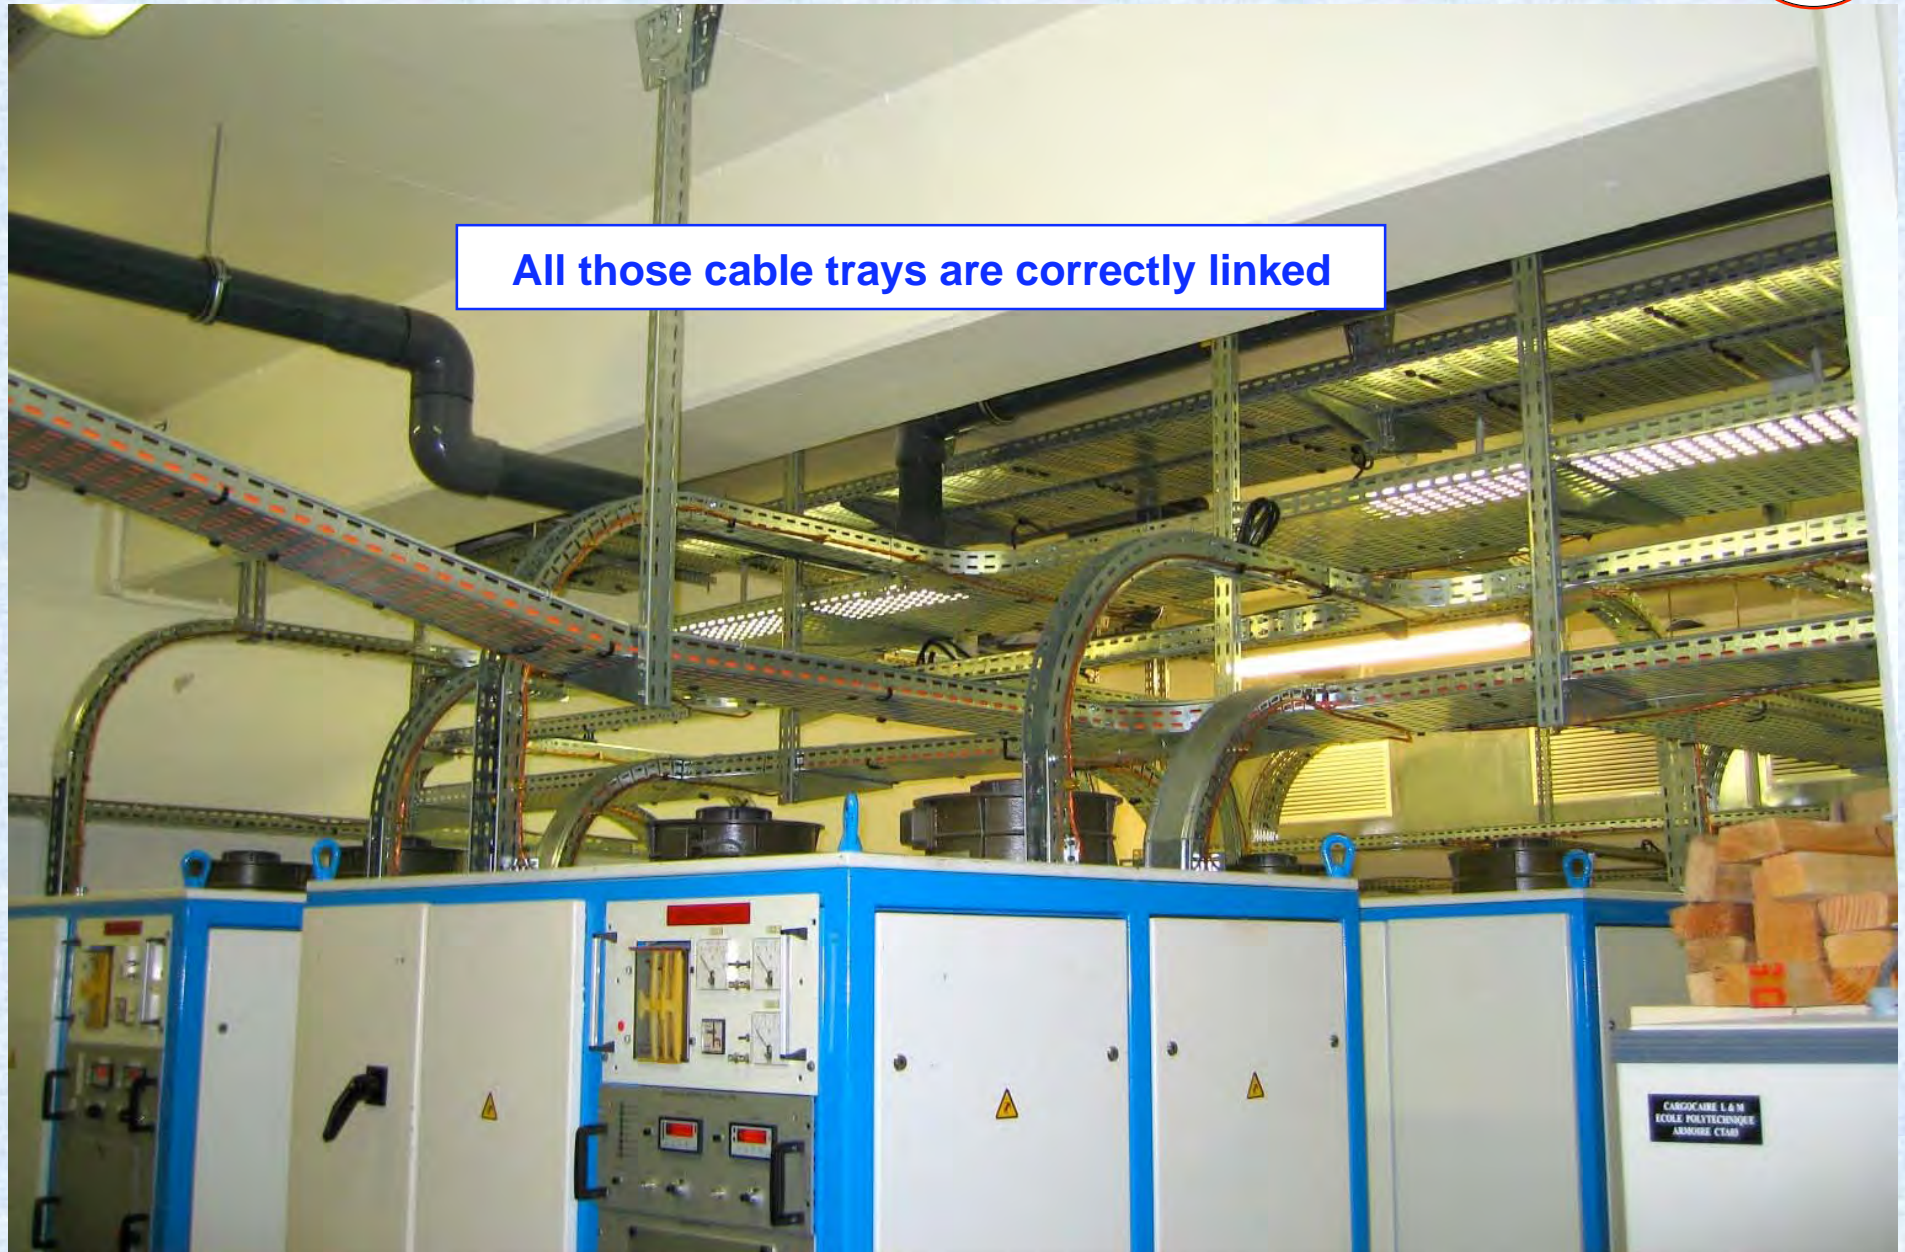
Correctly used cable trays

All those cable trays are correctly linked

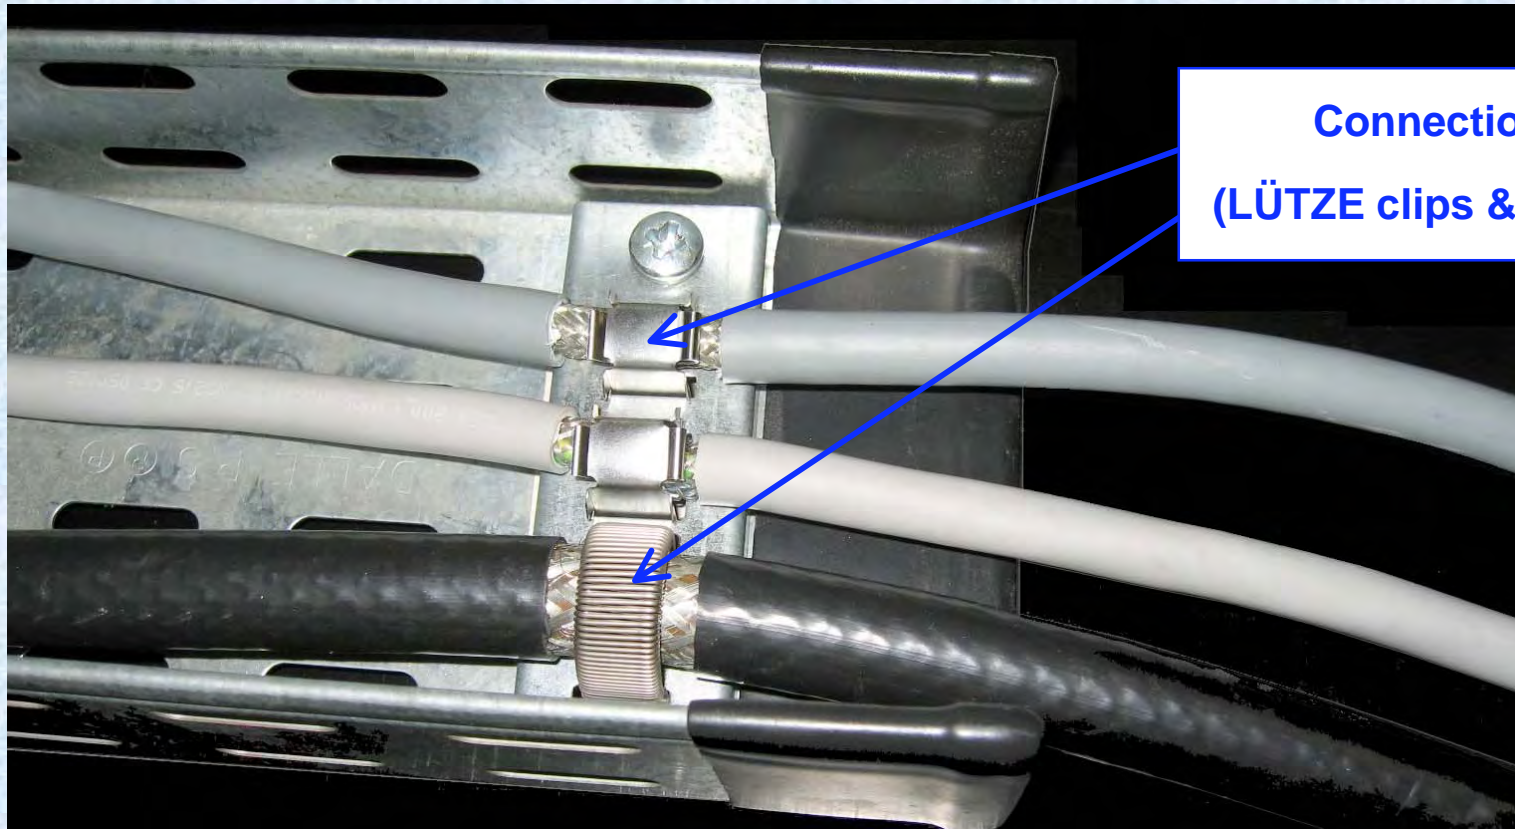
Some EMC alternatives - 2

Poor HF cable tray continuity

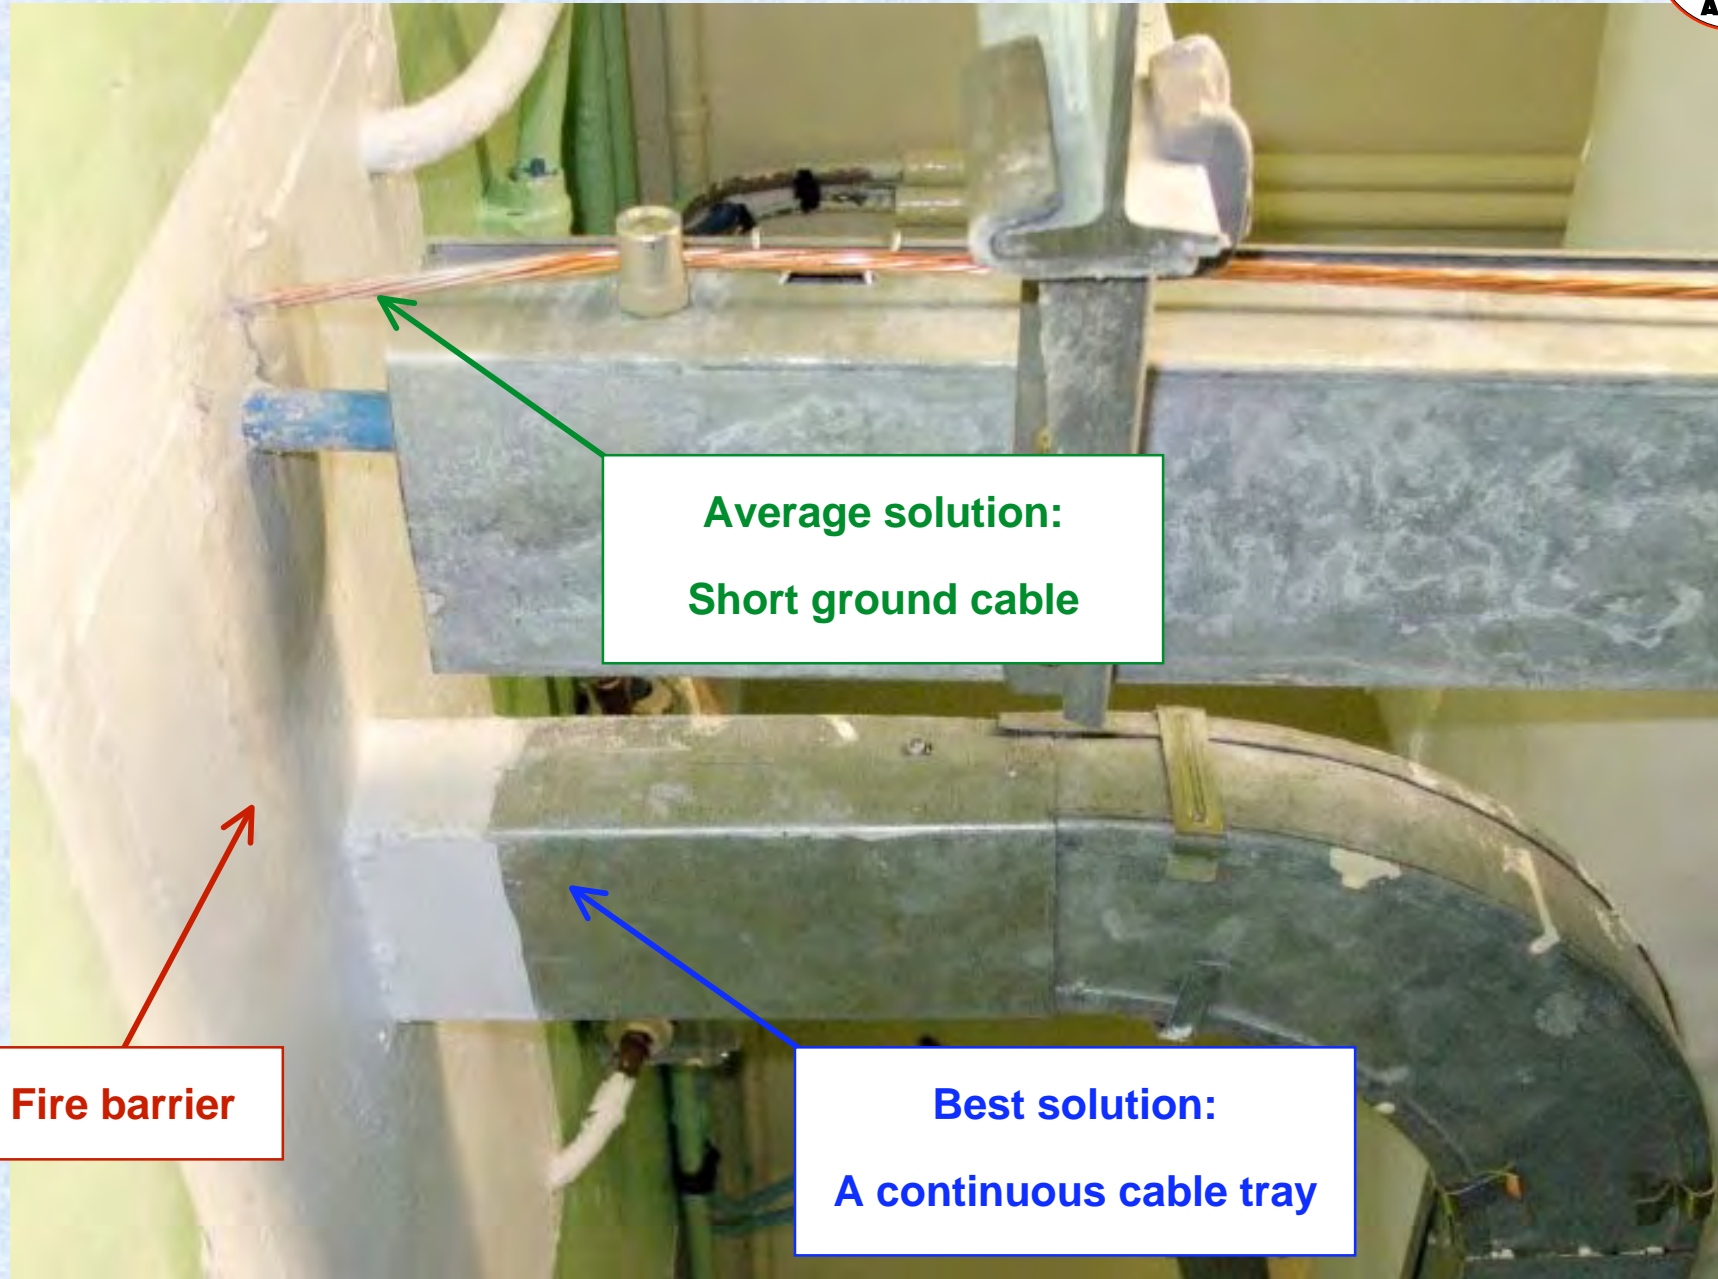
Some EMC alternatives - 3

Cable tray junction
(CES)

Average solution:
Short ground cable

Fire barrier

Best solution:
A continuous cable tray

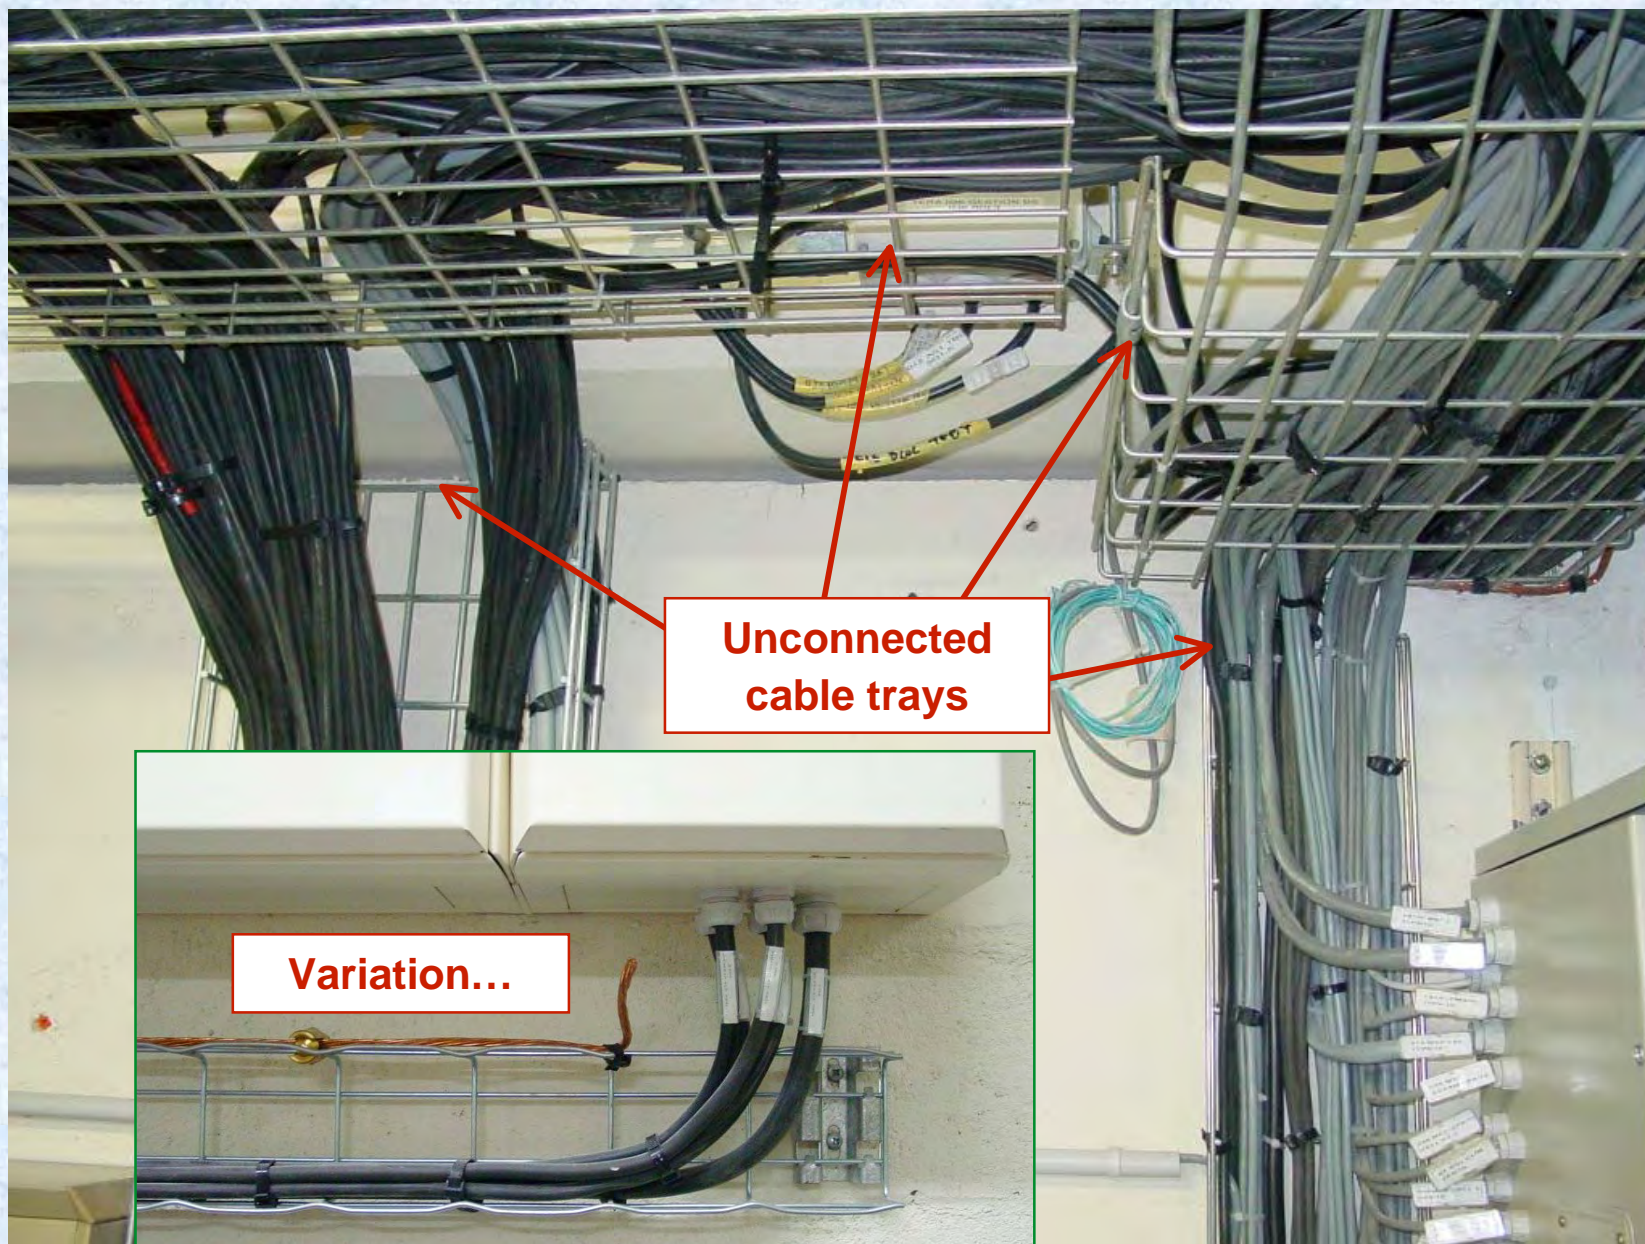
Usual EMC mistakes - 1

**Unconnected
cable trays**

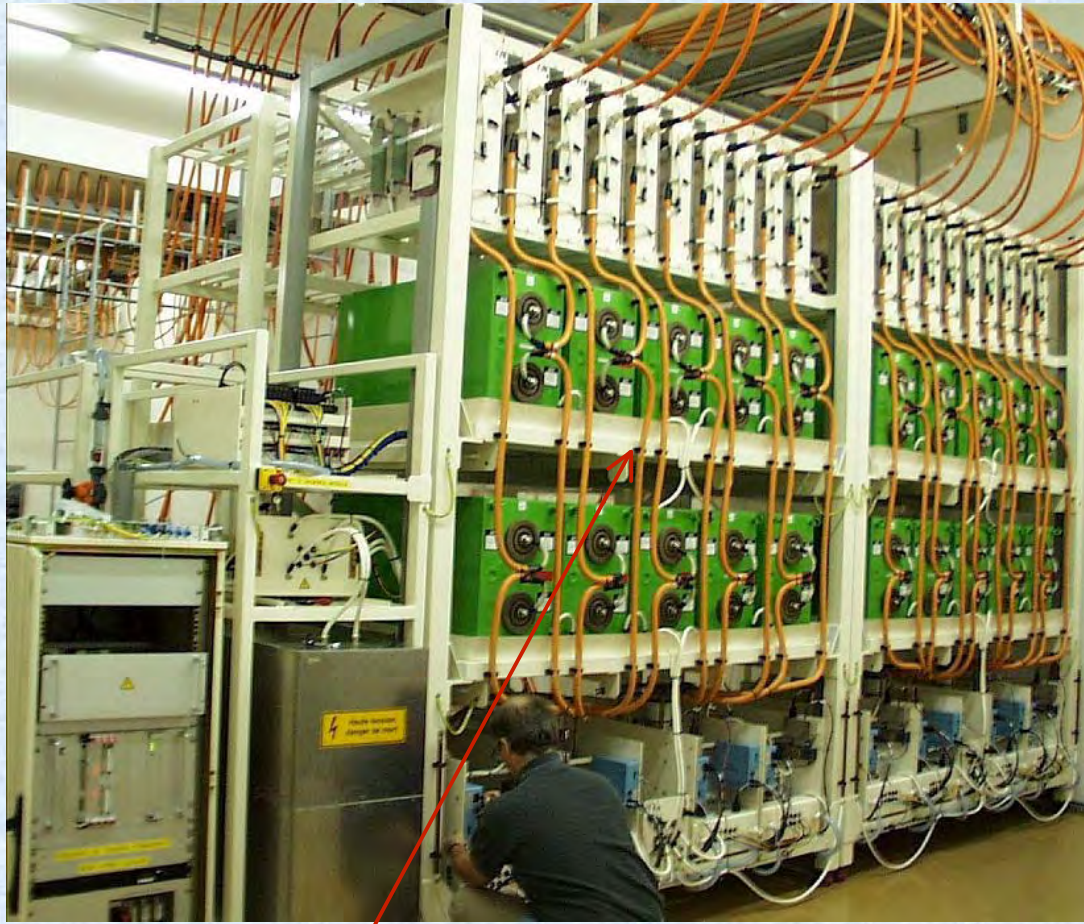
**m² of radiating loops
(with kAmps pulses)**

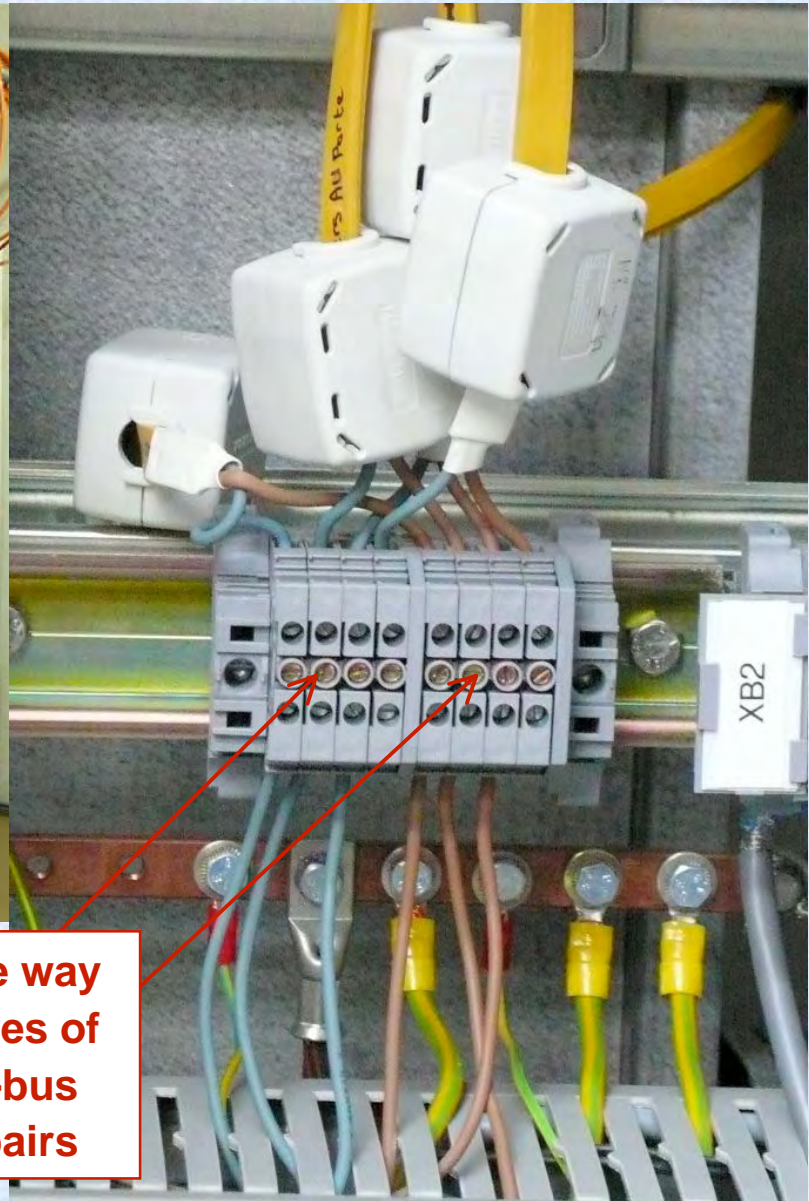
**Separated one way
and return wires of
those 4 field-bus
unshielded pairs**

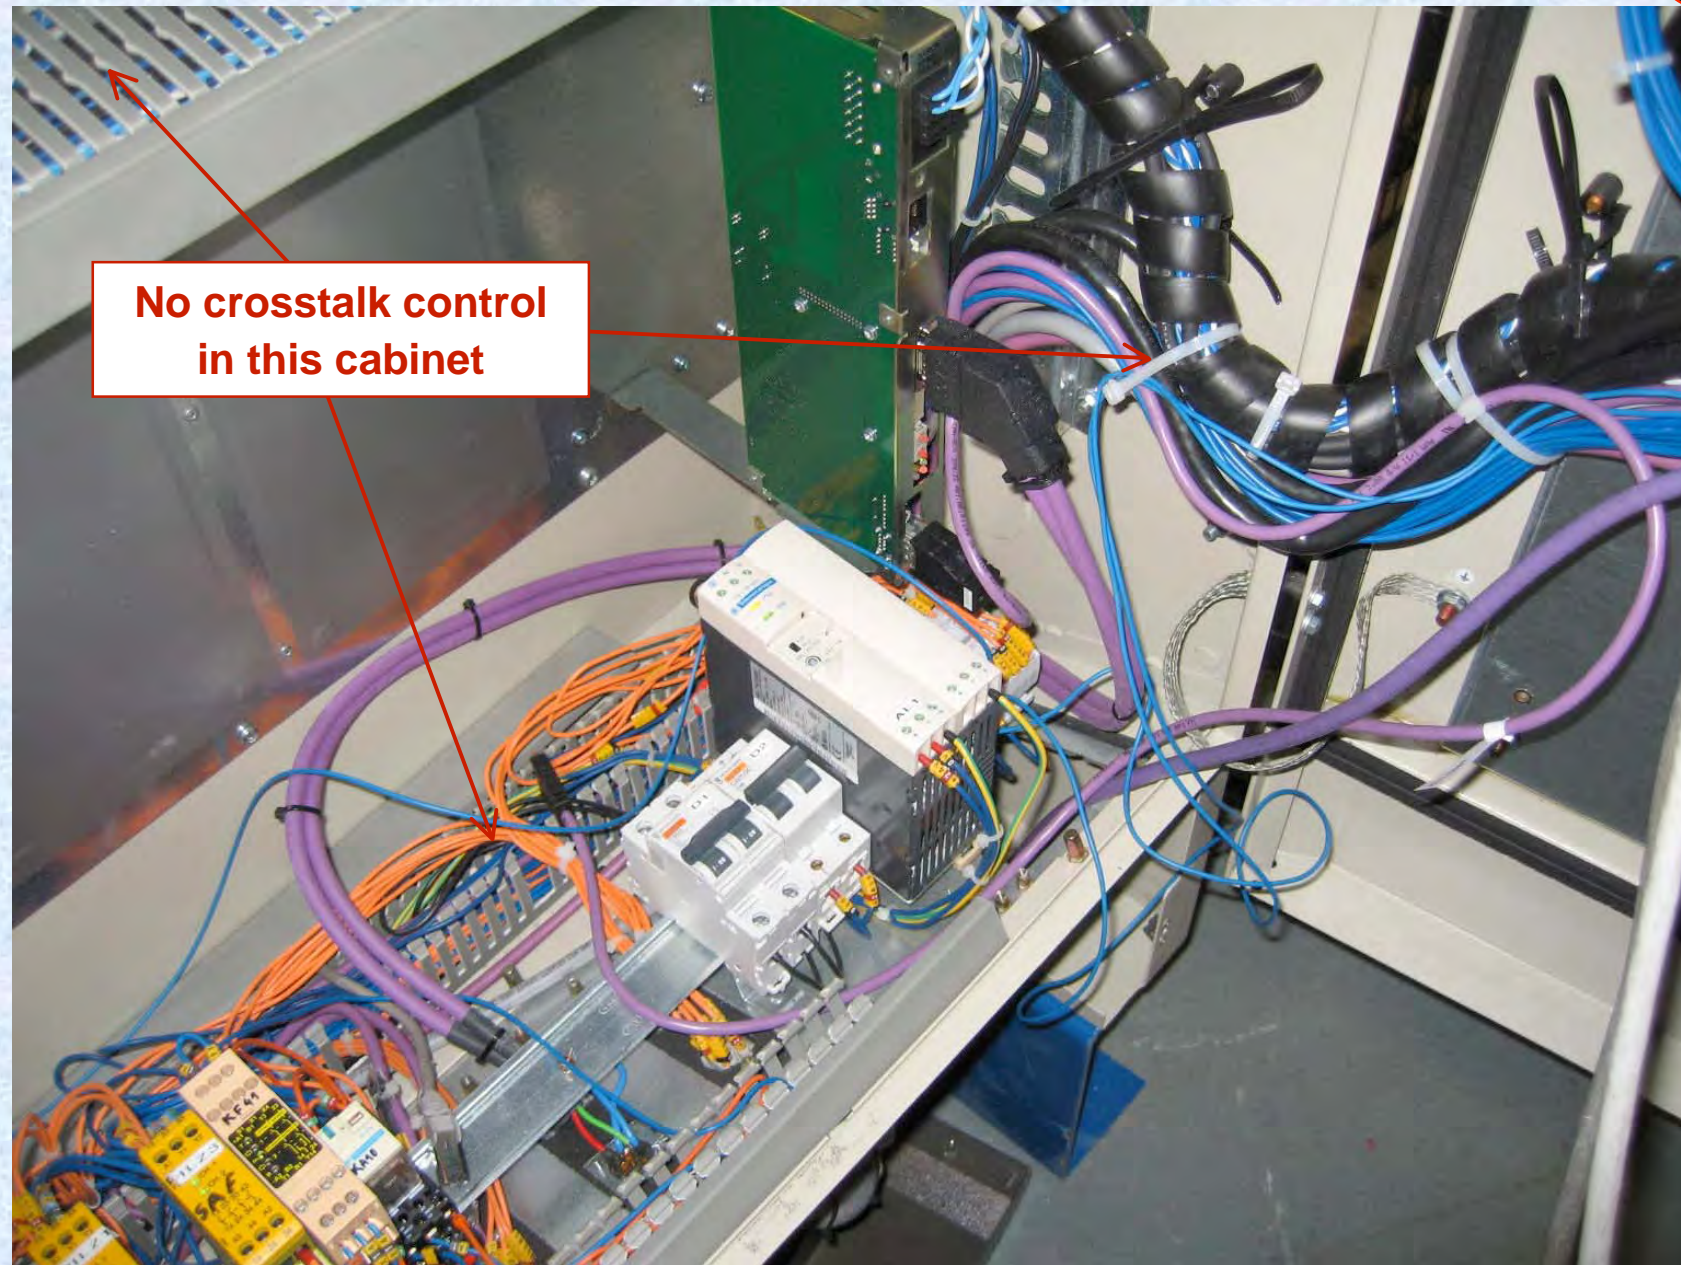
Usual EMC mistakes - 3

**No crosstalk control
in this cabinet**

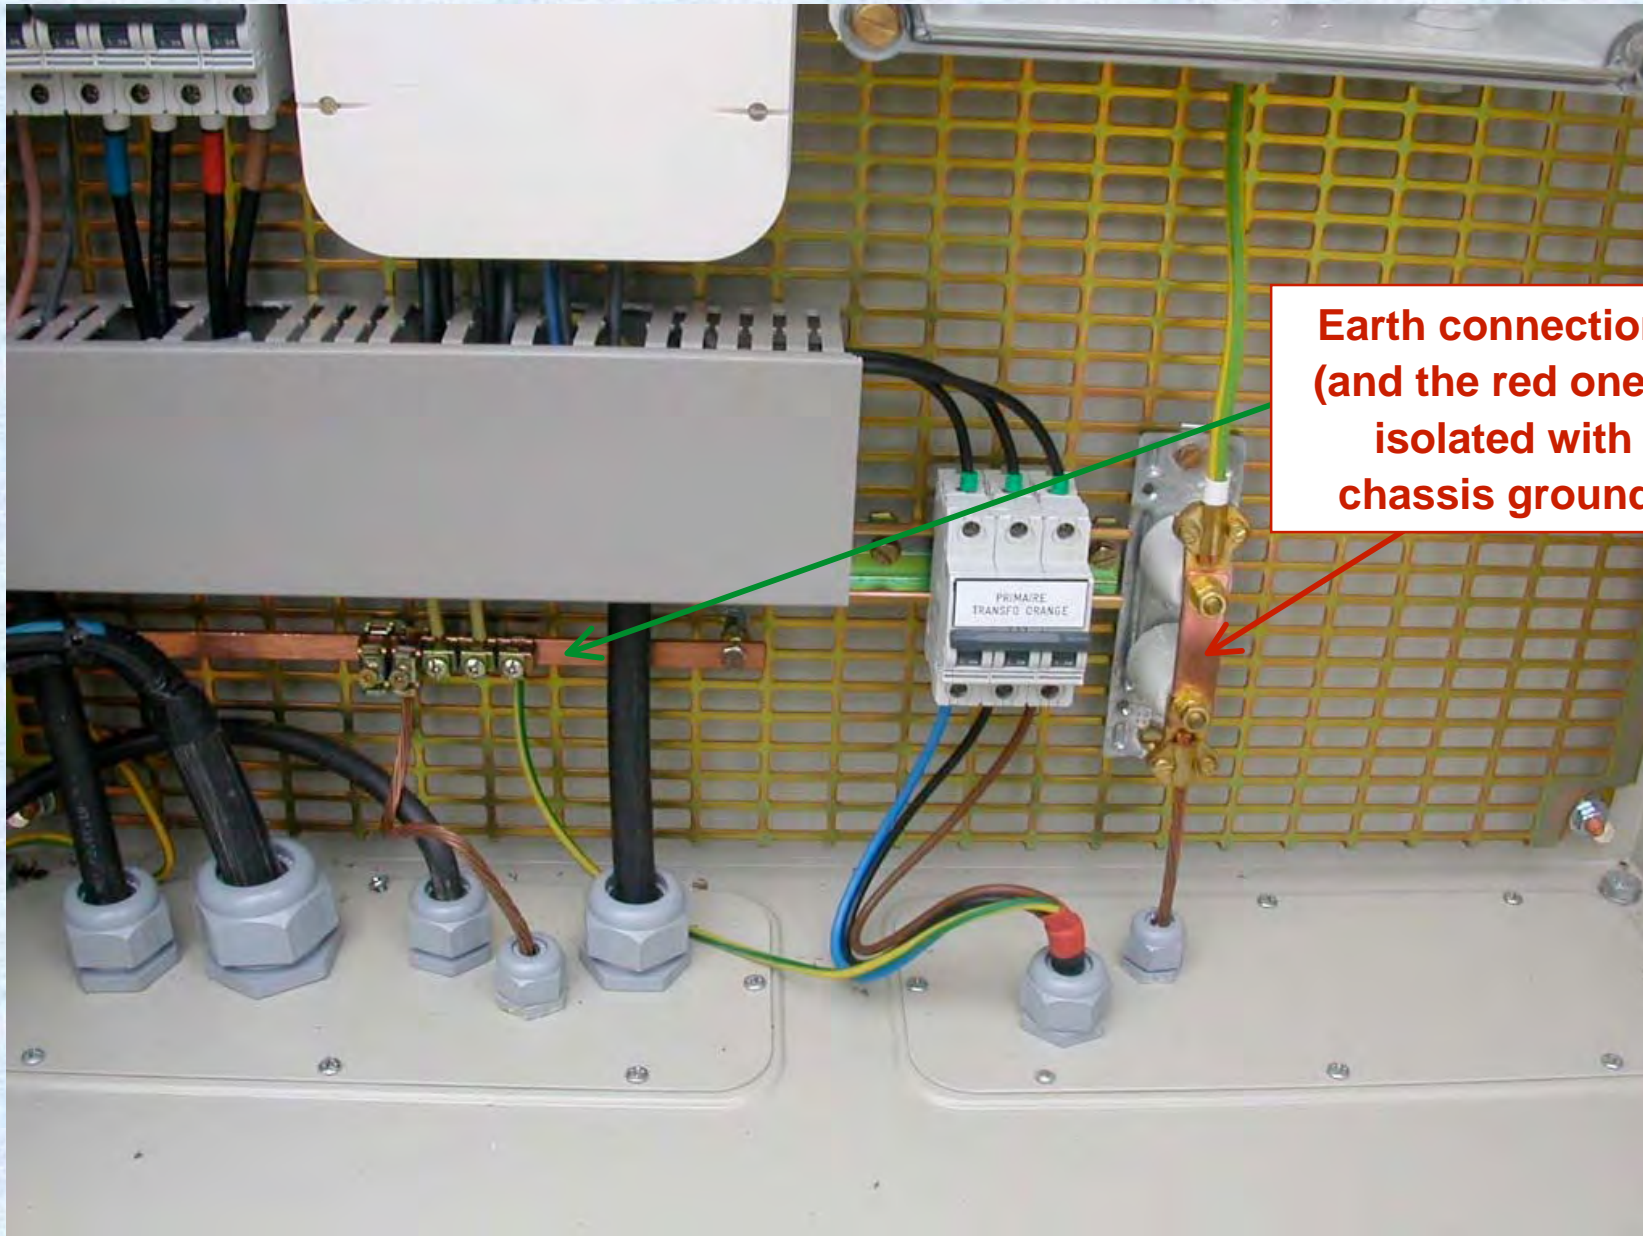
Usual EMC mistakes - 4

Earth connections
(and the red one is
isolated with
chassis ground)

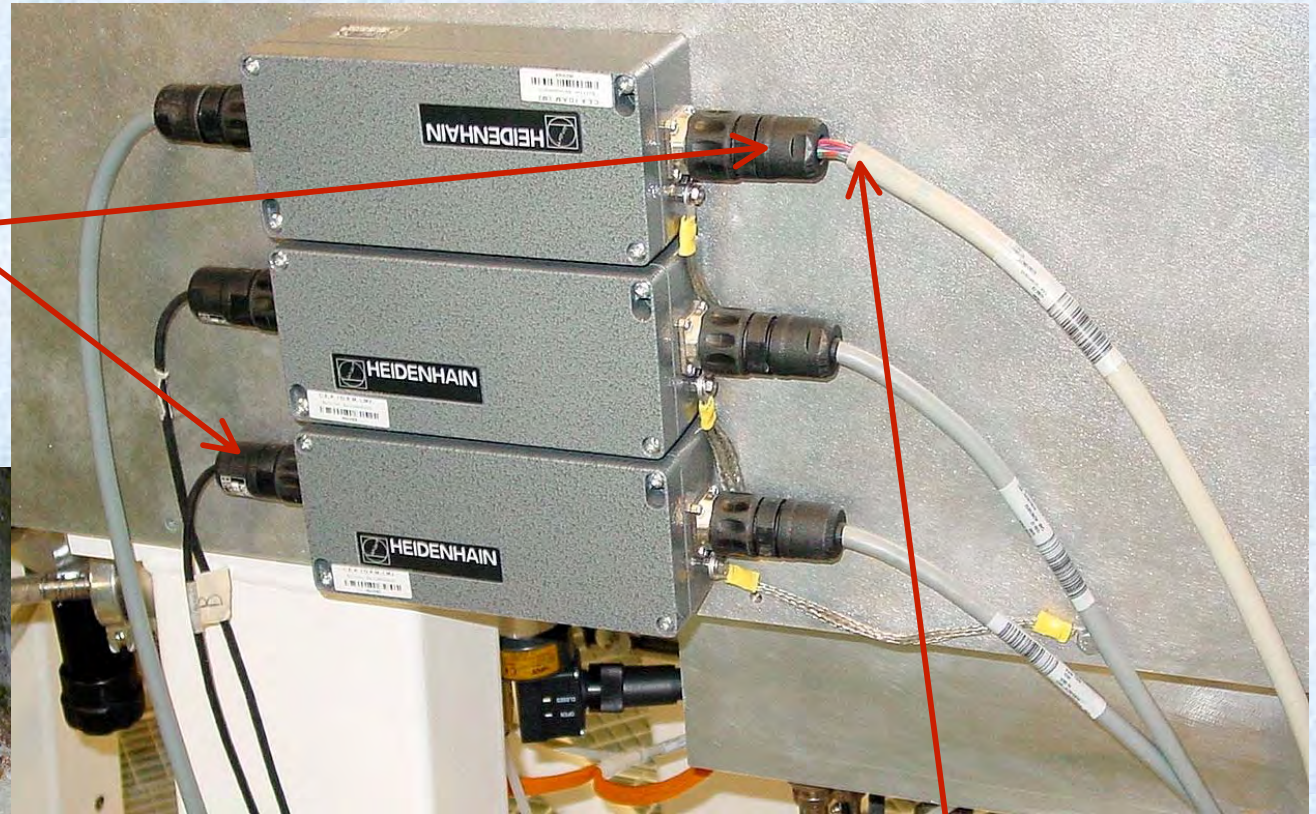
Plastic connectors

Unshielded signal cable

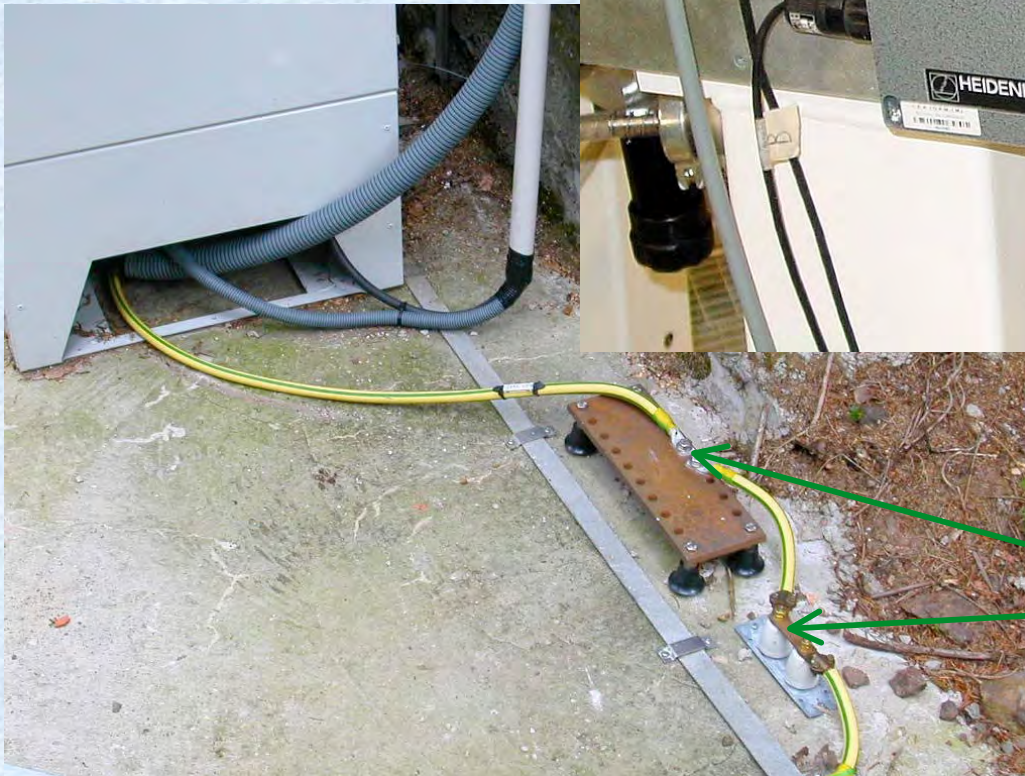
Useless terminals in series

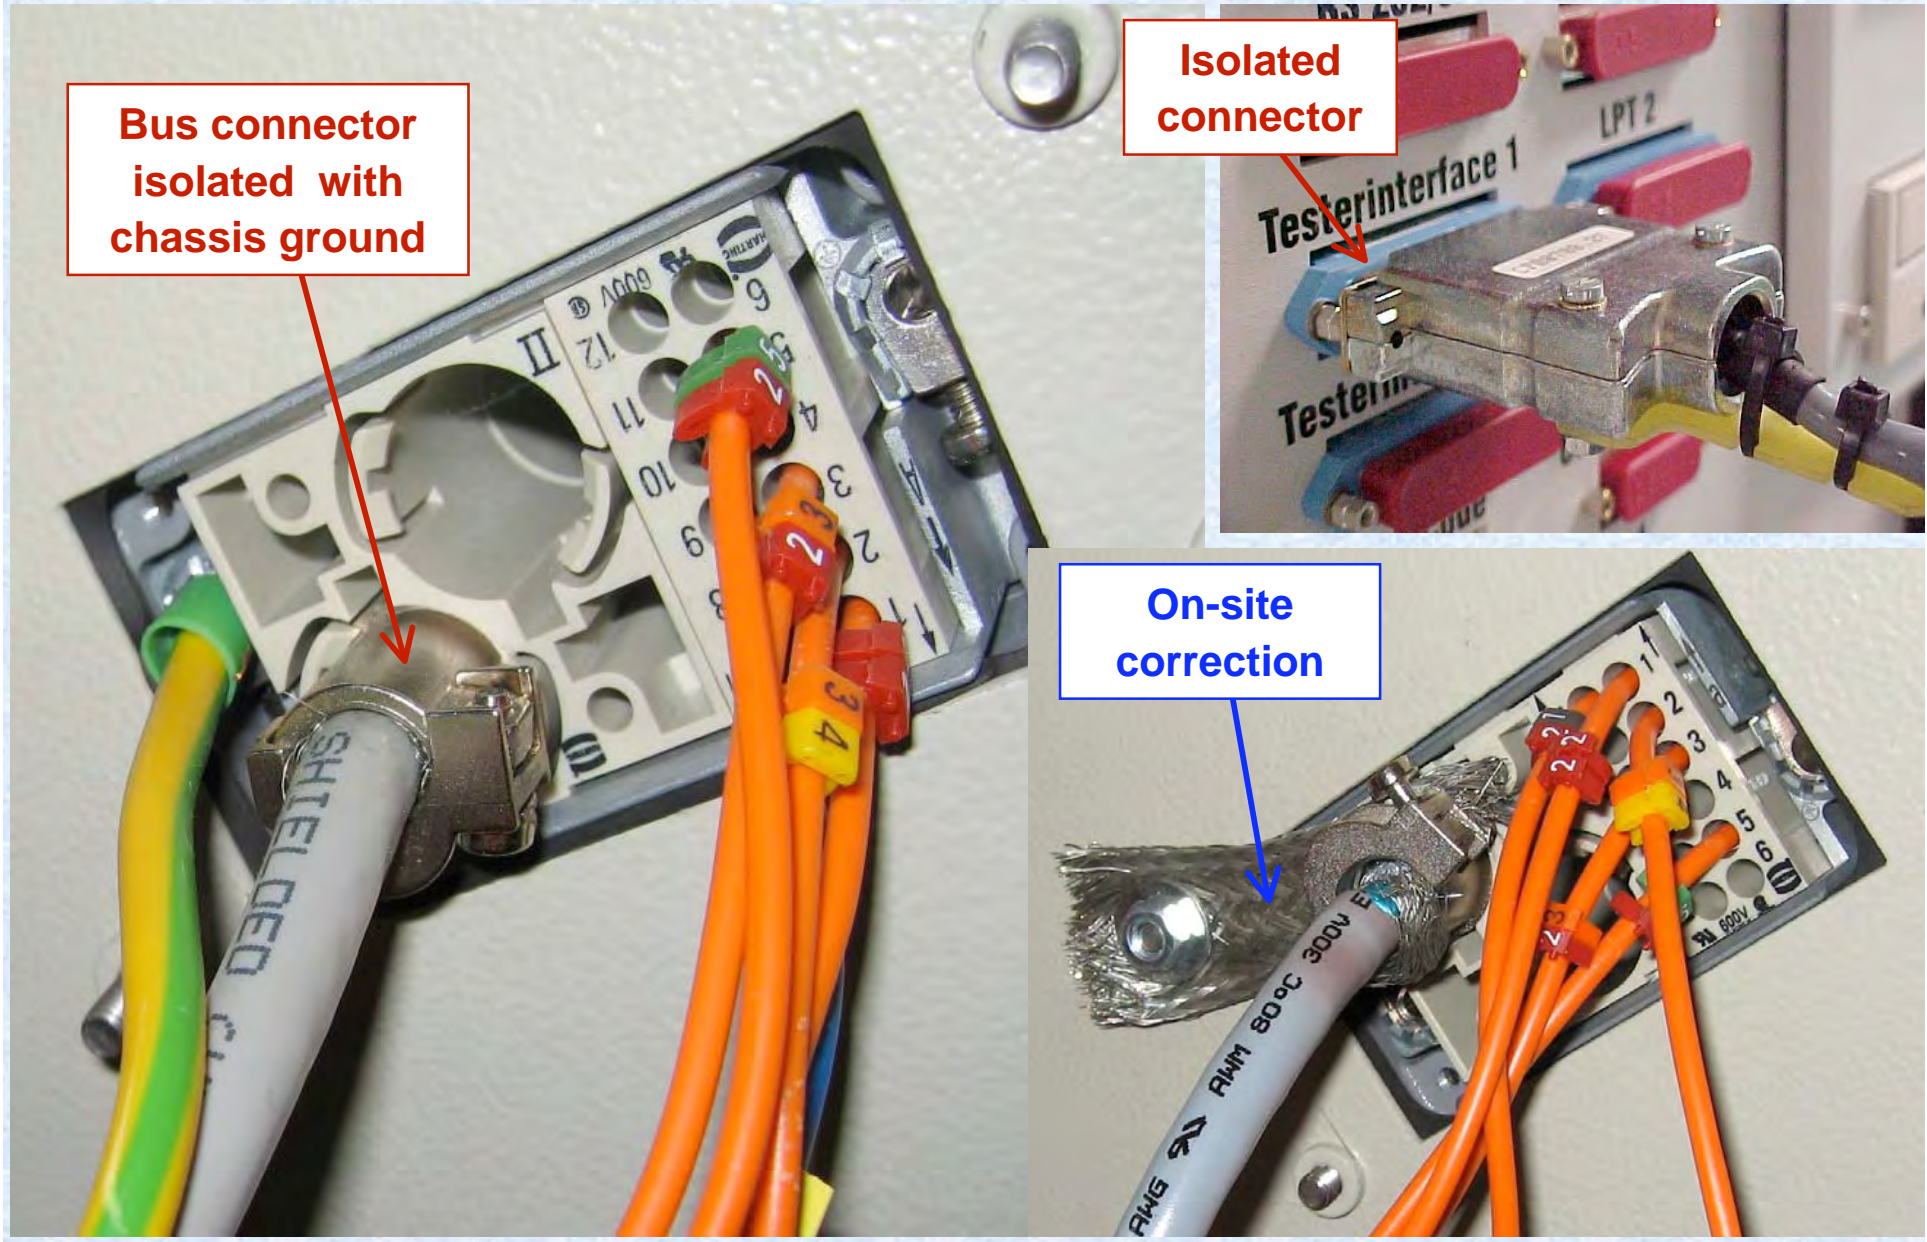
Usual EMC mistakes - 6

Bus connector
isolated with
chassis ground

Isolated
connector

On-site
correction
