ElectroMagnetic Interference

Recurrent EMI mistakes - Good & poor practical fixes

Alain CHAROY - (0033) 4 76 49 76 76 - a.charoy@aemc.fr

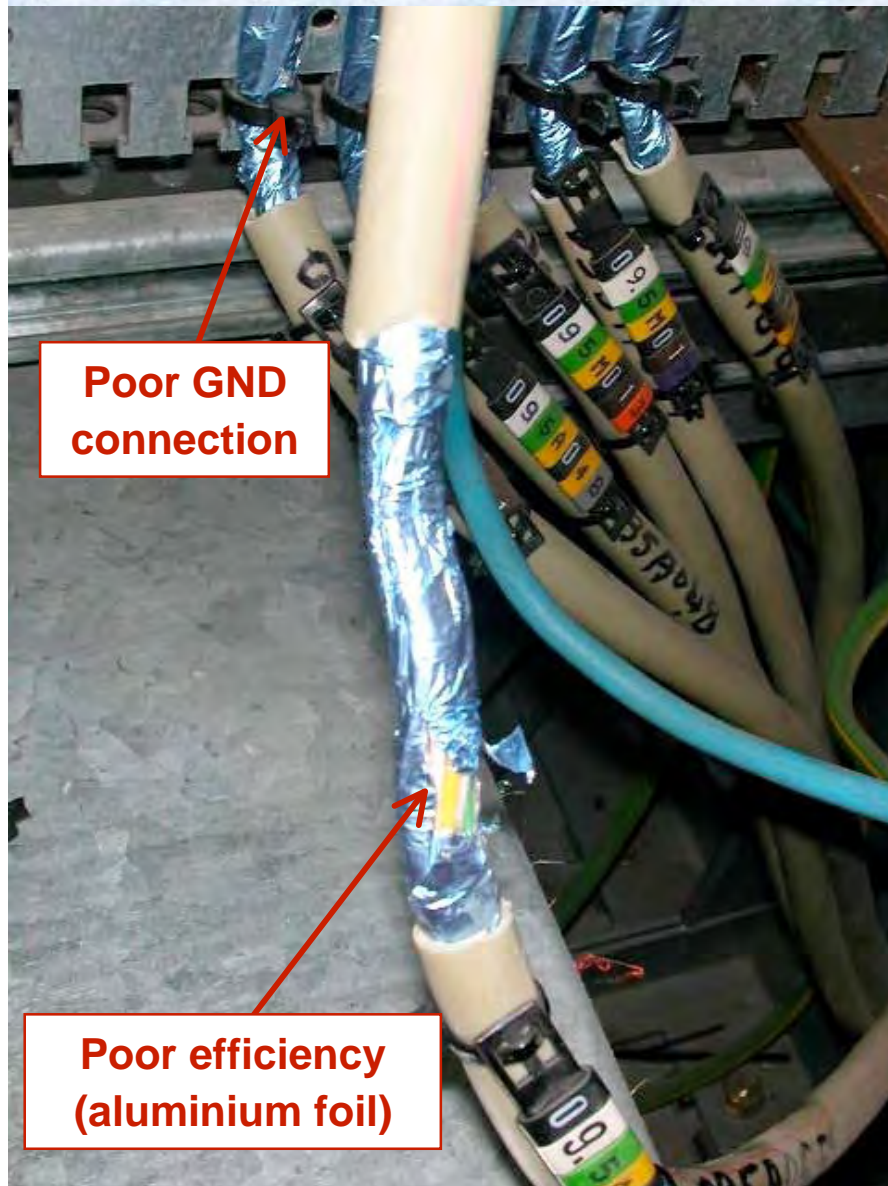
Poor GND connection

Poor efficiency (aluminium foil)

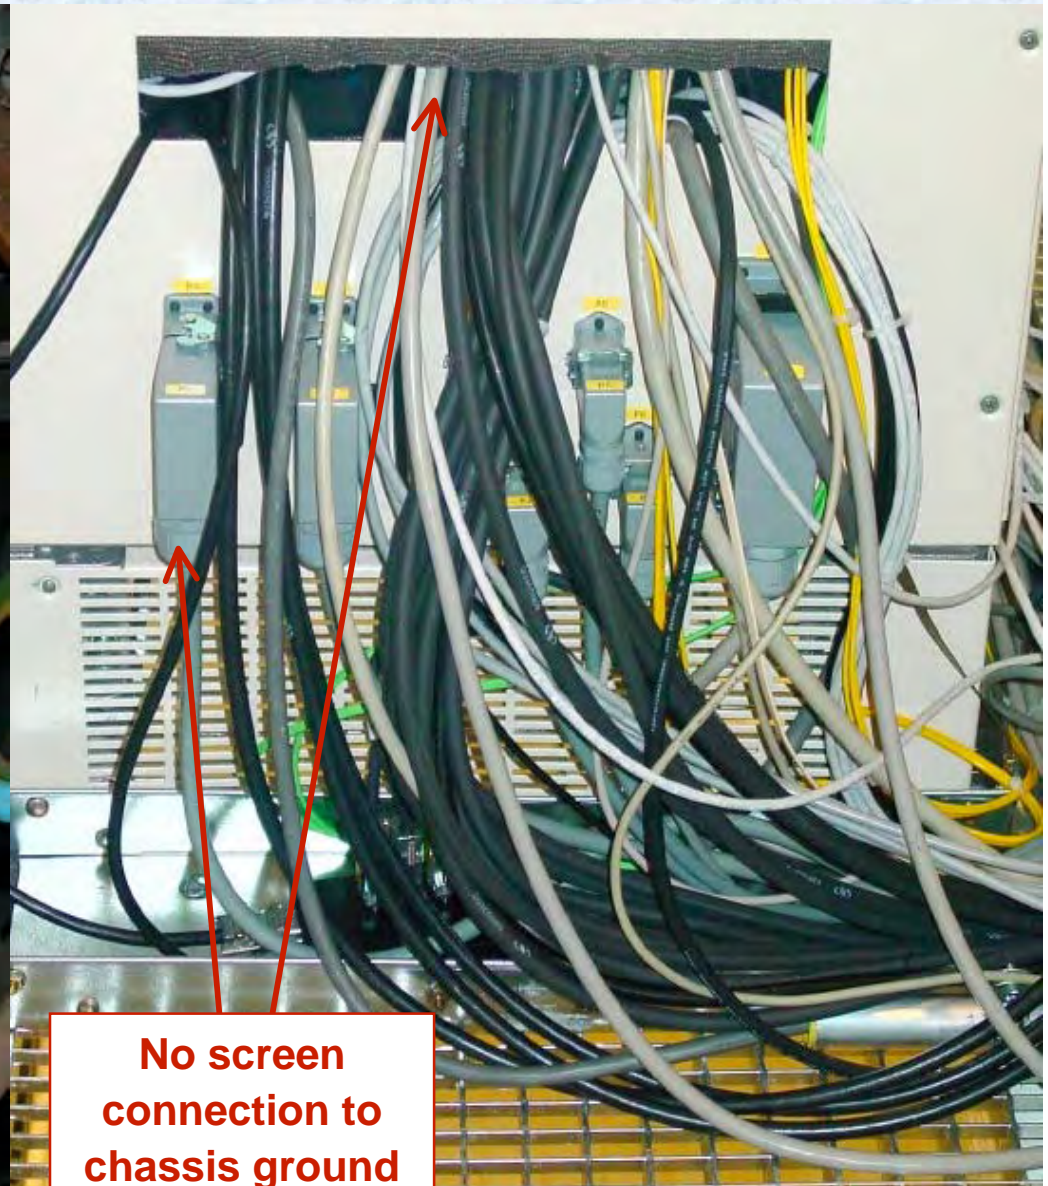
No screen connection to chassis ground

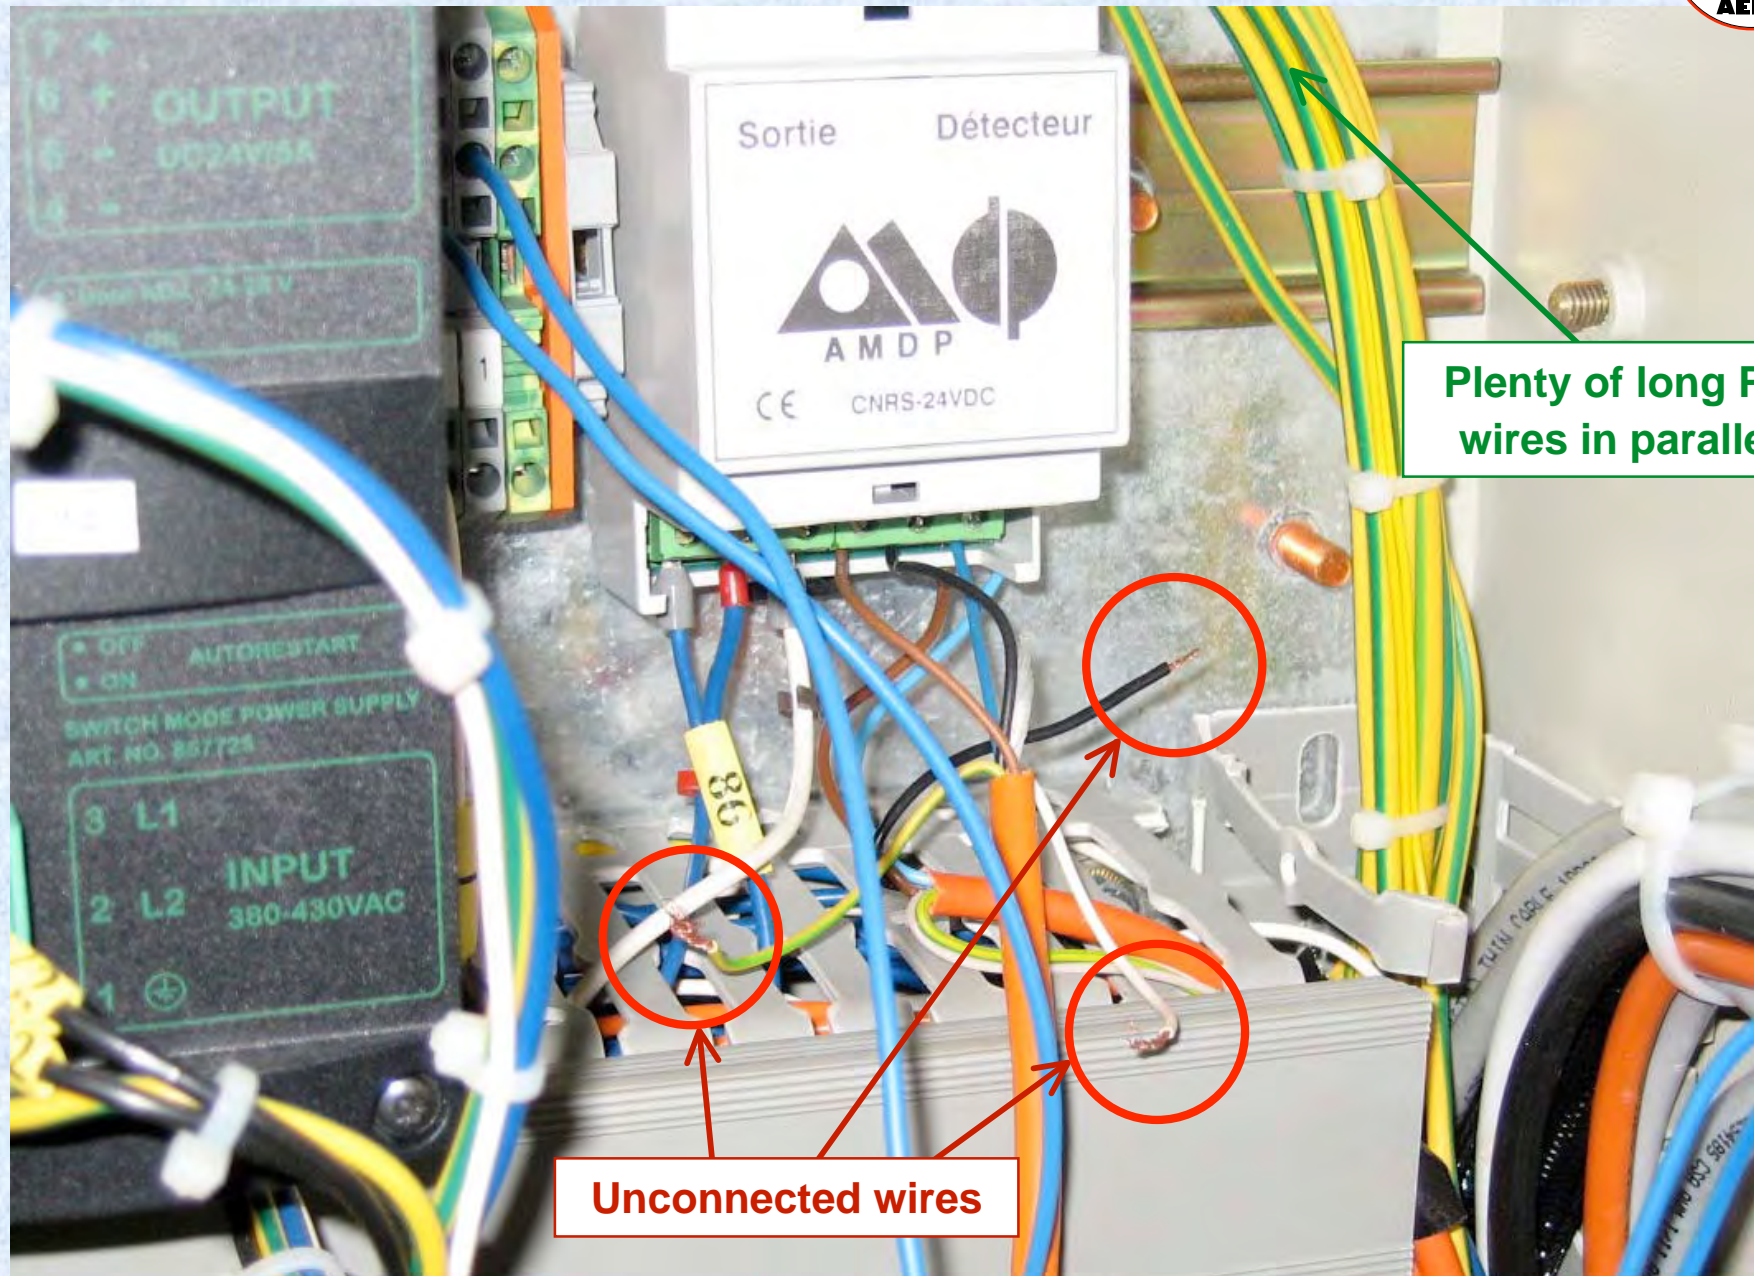
Usual EMC mistakes - 9

Plenty of long PE wires in parallel

Unconnected wires

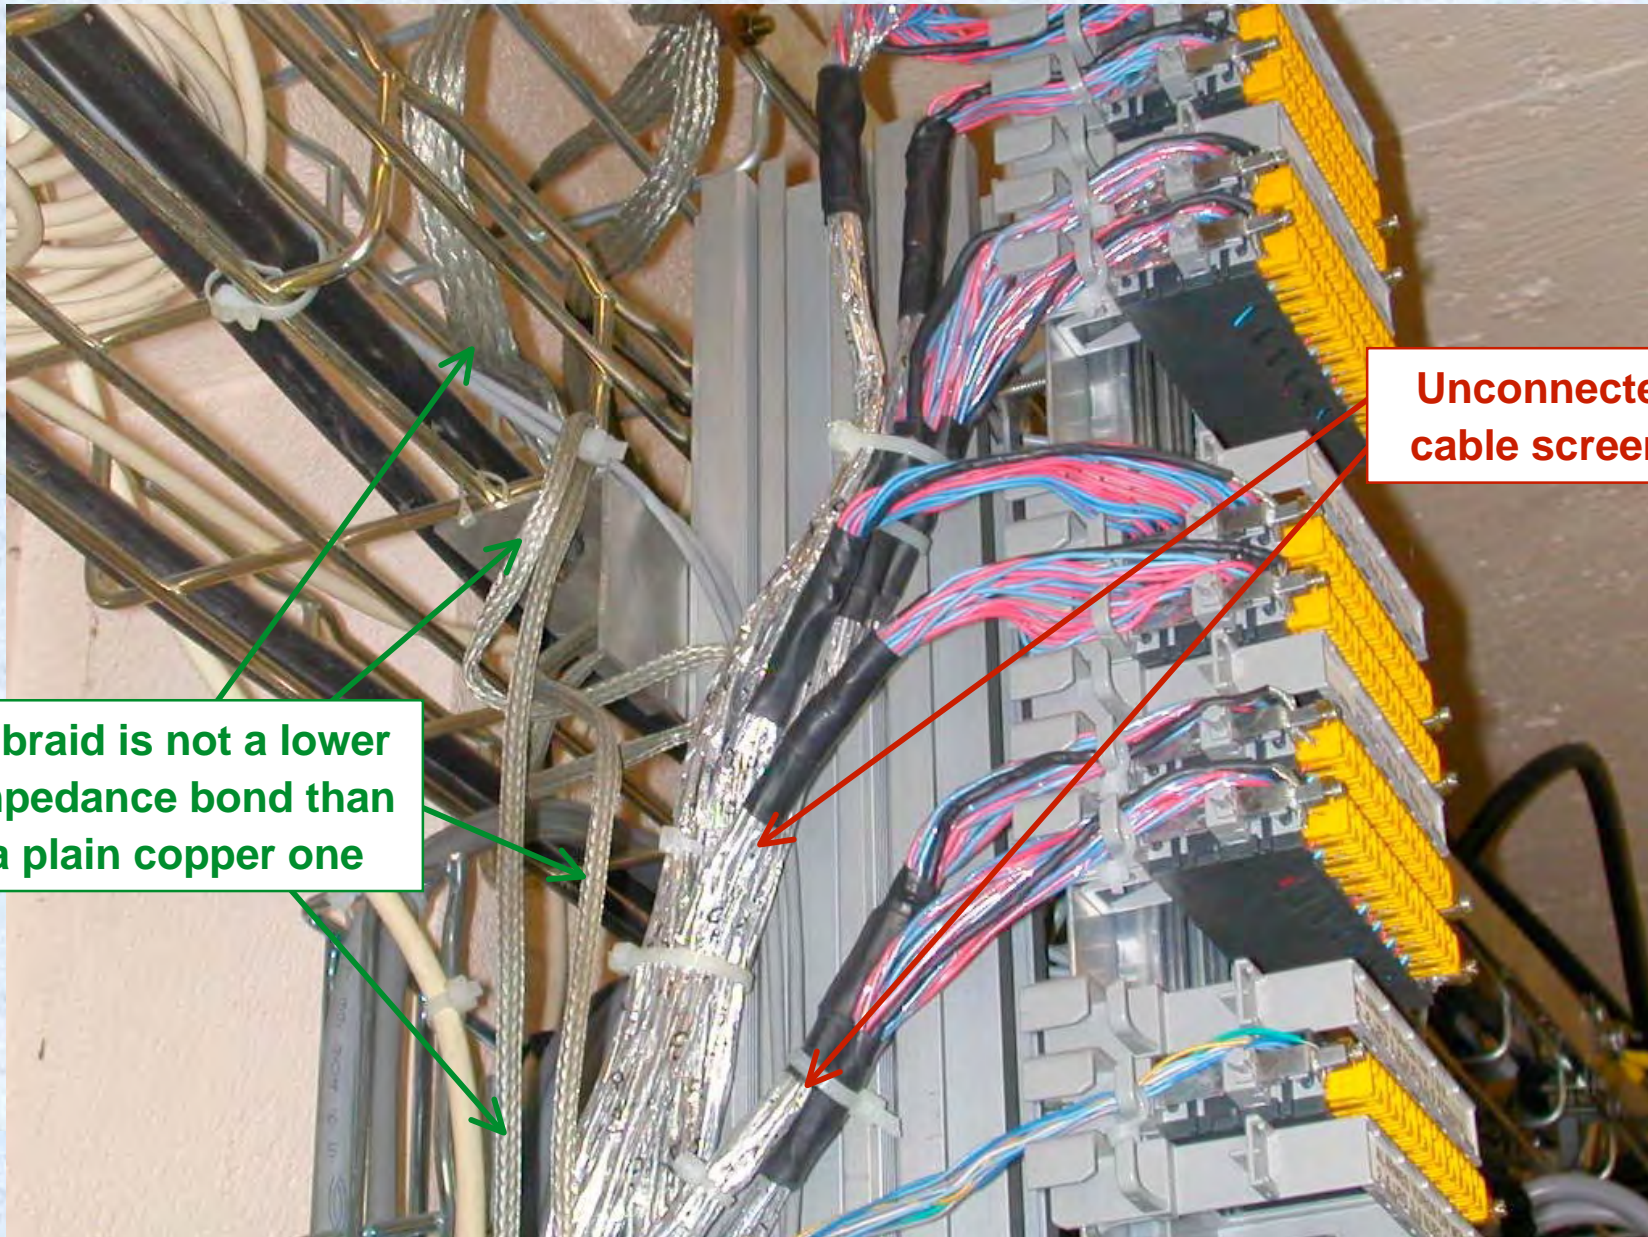
Usual poor EMC fixes - 3

A braid is not a lower impedance bond than a plain copper one

Unconnected cable screens

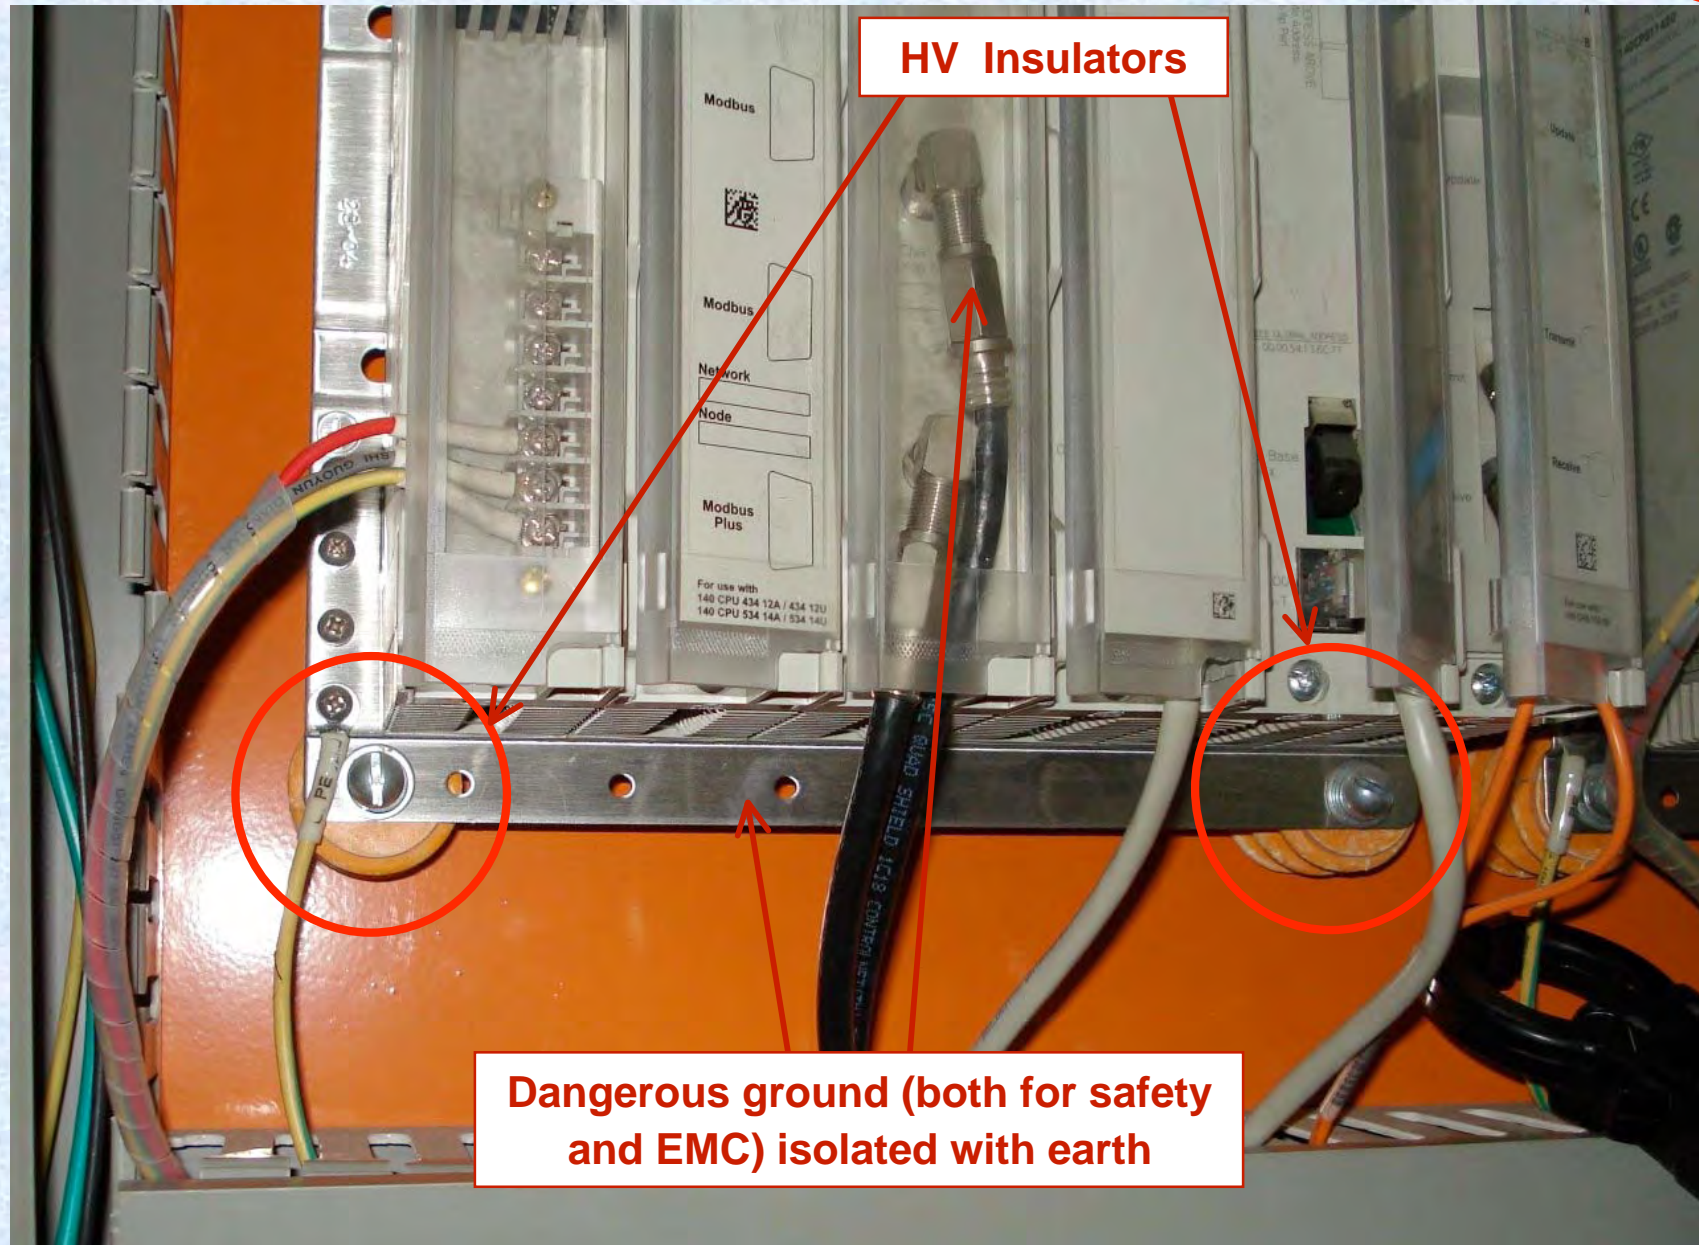
Usual poor EMC fixes - 4

HV Insulators

Dangerous ground (both for safety and EMC) isolated with earth

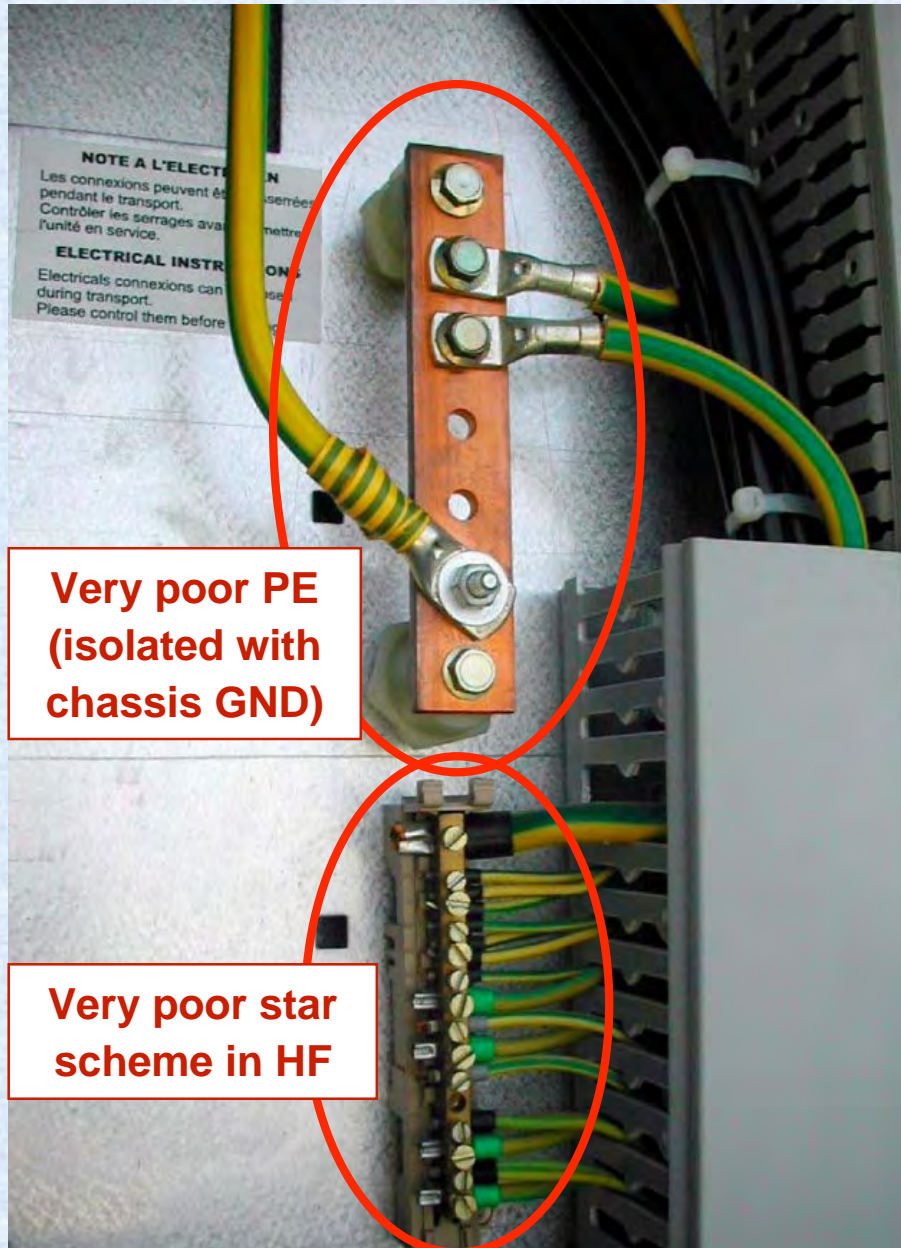
**Very poor PE
(isolated with
chassis GND)**

**Very poor star
scheme in HF**

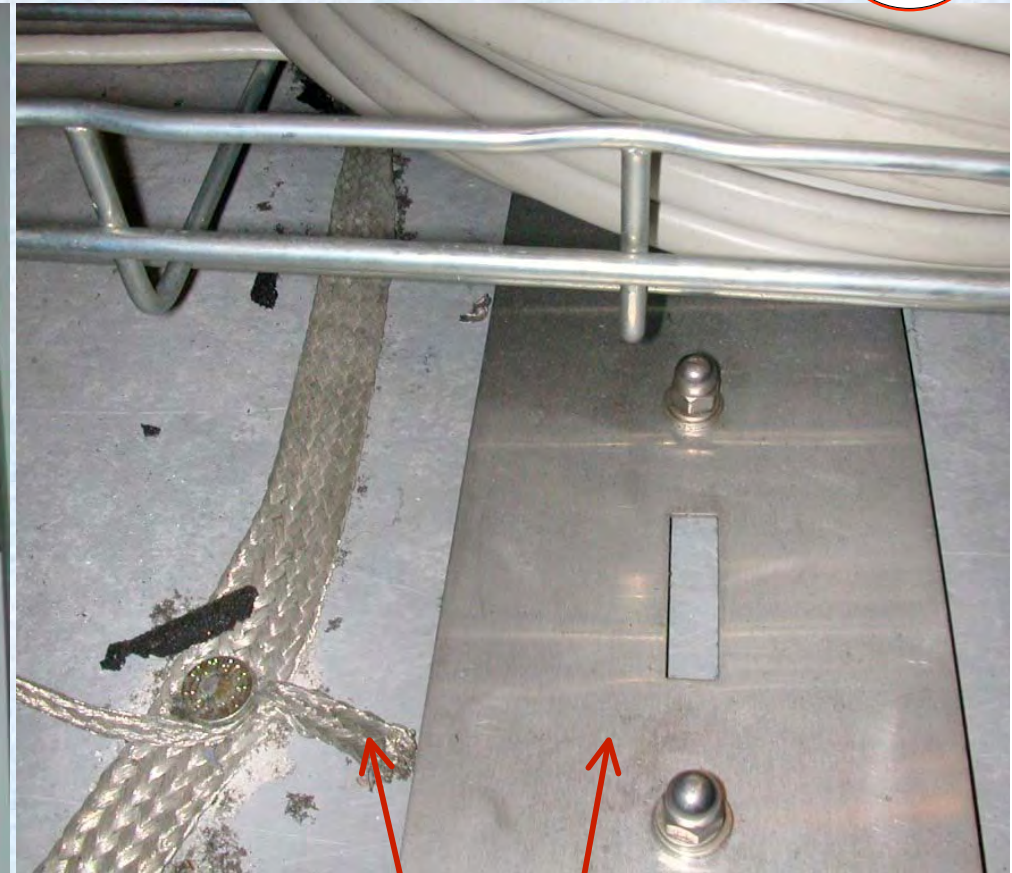
**Poor added ground grid
(no contact between the braid
and the stainless steel plate)**

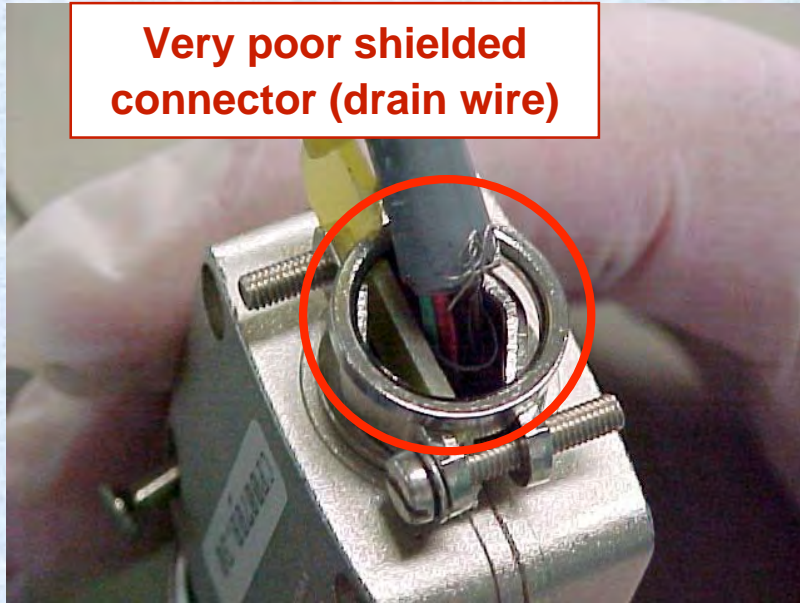
Very poor shielded connector (drain wire)

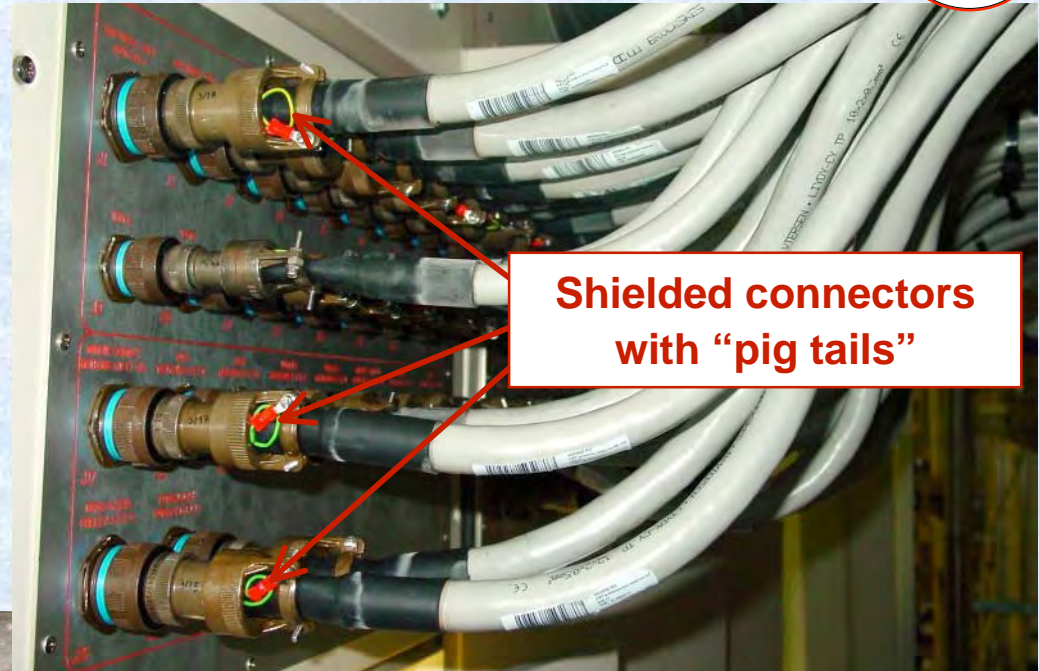
Shielded connectors with "pig tails"

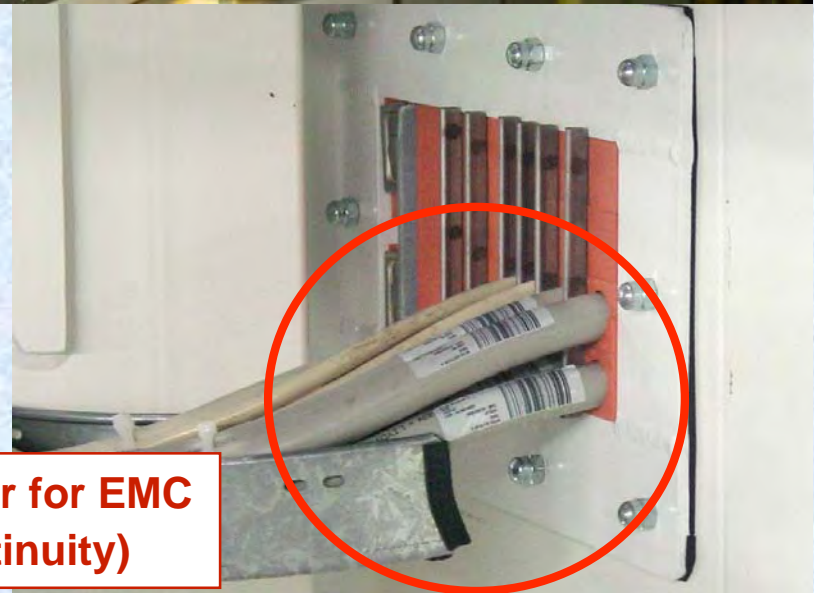
Fire barriers very poor for EMC (no cable tray continuity)

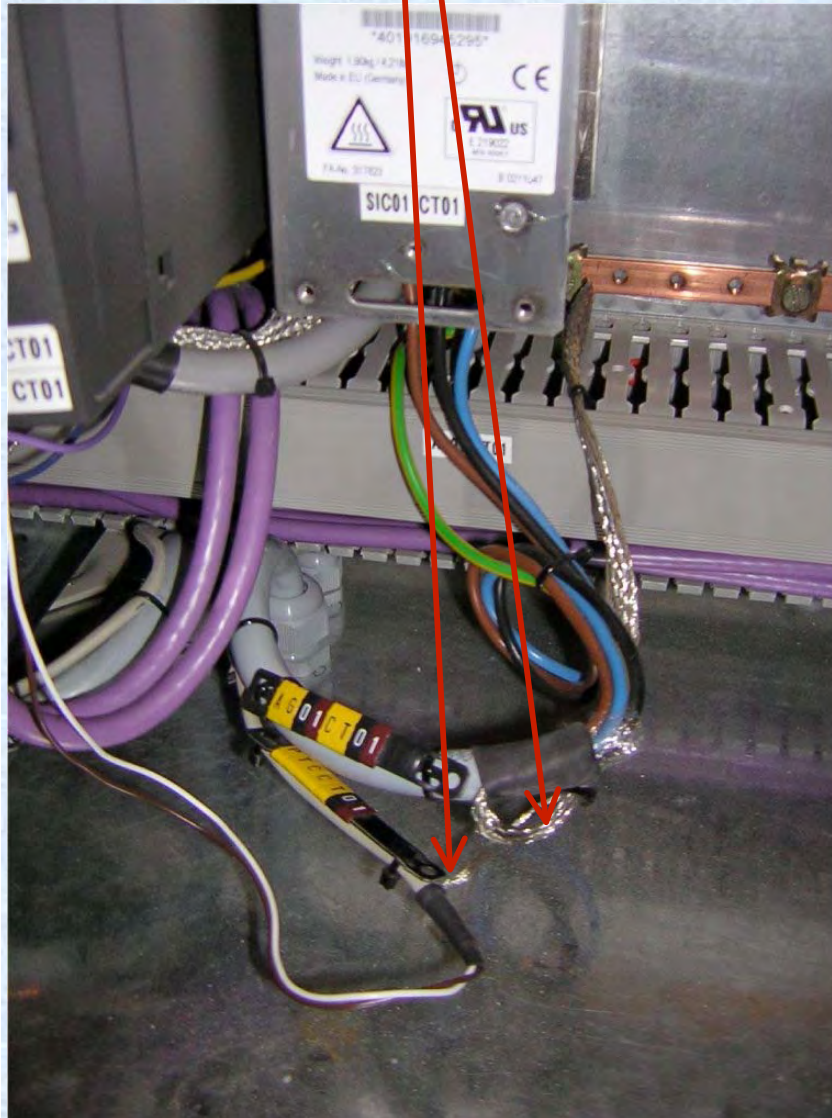
Too long pig tails

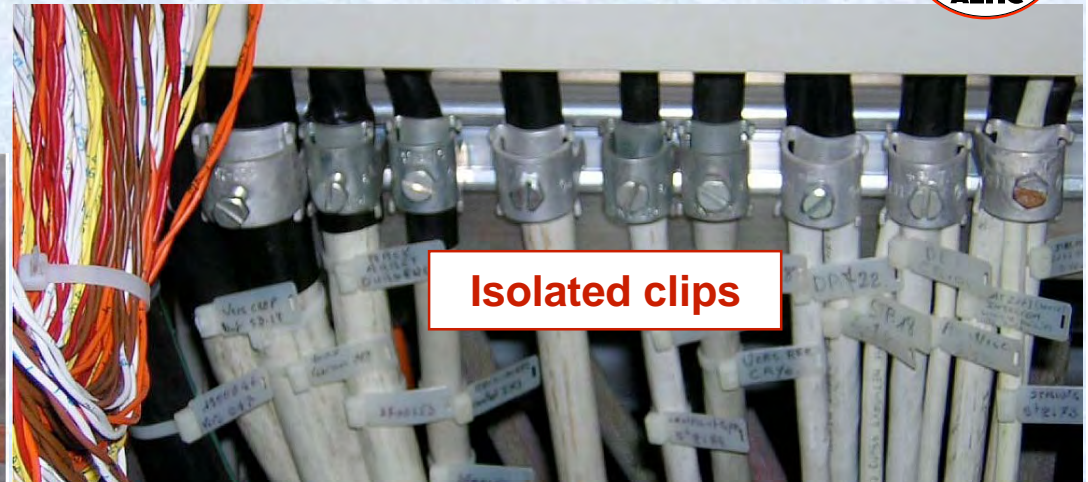
Isolated clips

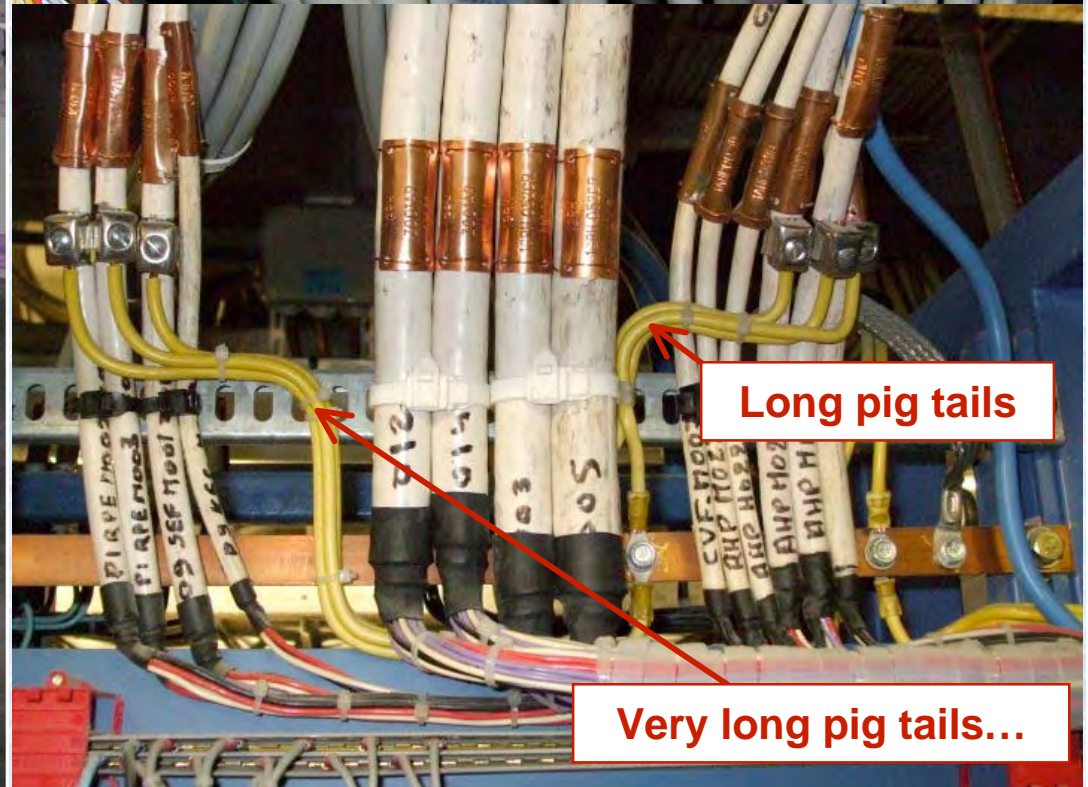
Long pig tails

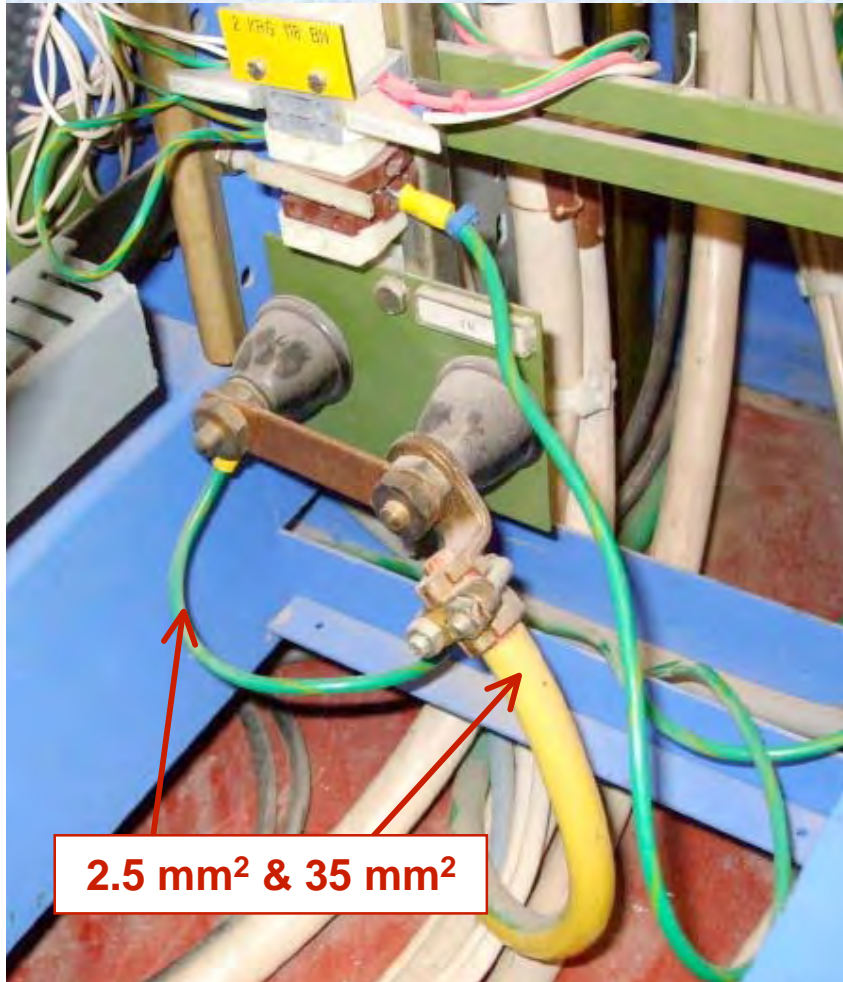
2.5 mm² & 35 mm²

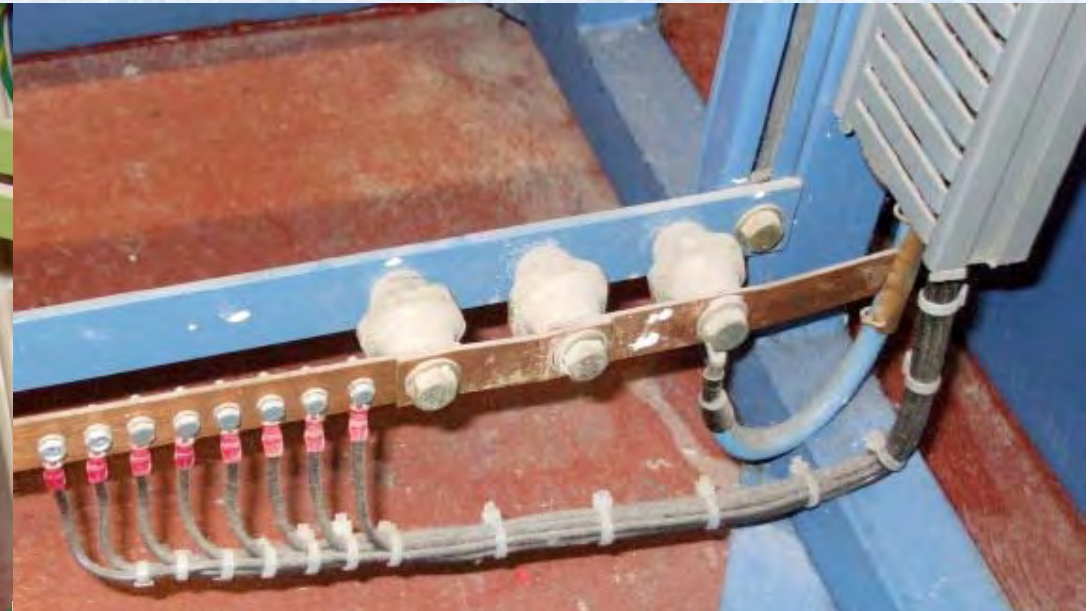
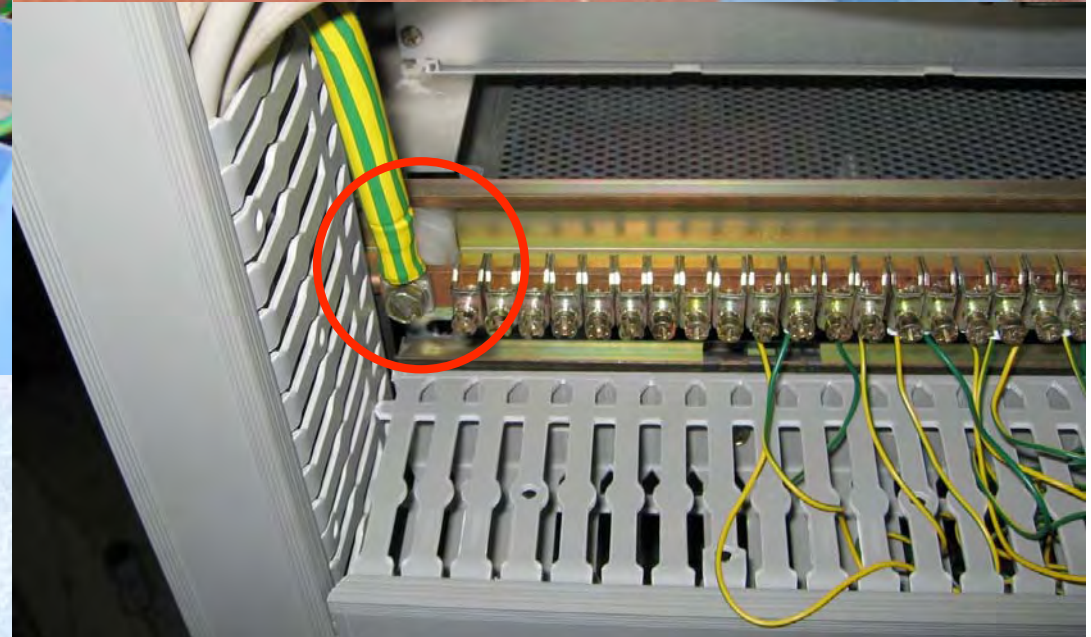
Separate grounds...
and star grounding
