FAILURES AND MISCONCEPTIONS

- **AIM OF THE TALK**

- DESCRIBE FAILURES
- SHOW THEIR ORIGIN (MISCONCEPTIONS)
- DETERMINE WHAT WAS WRONG
- DRAW ATTENTION ON BEHAVIOR/PROCEDURES LEADING TO FAILURE

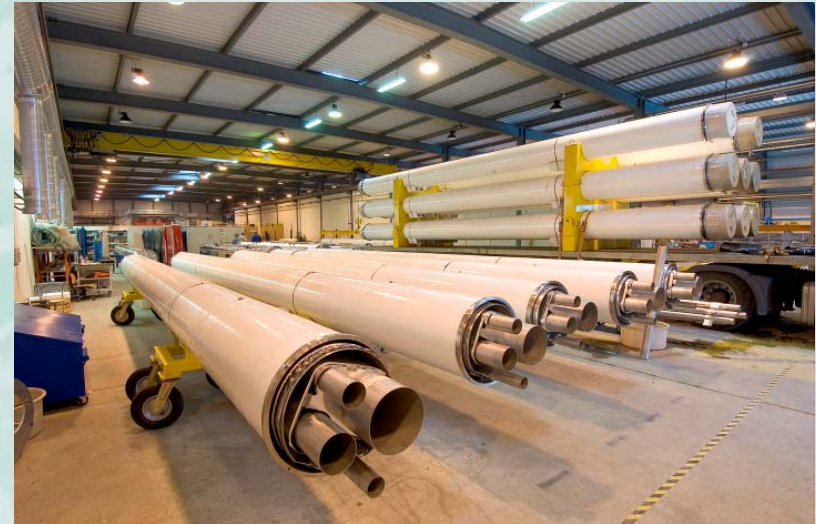
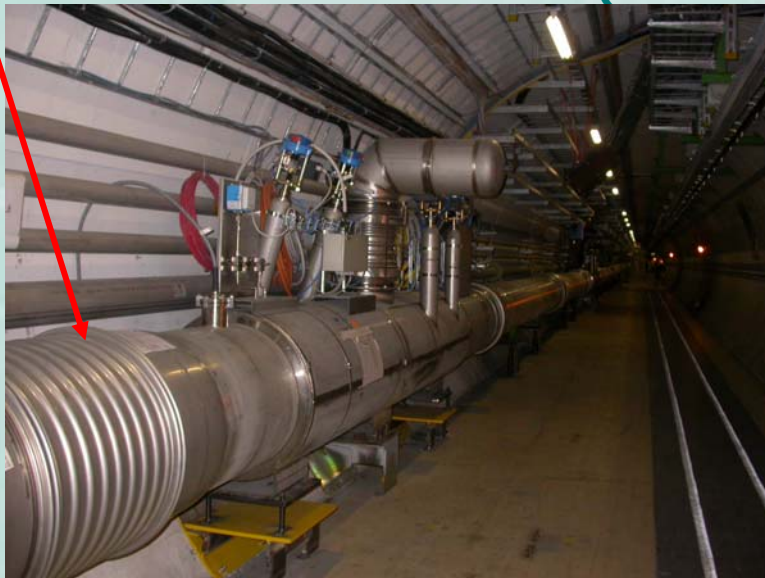
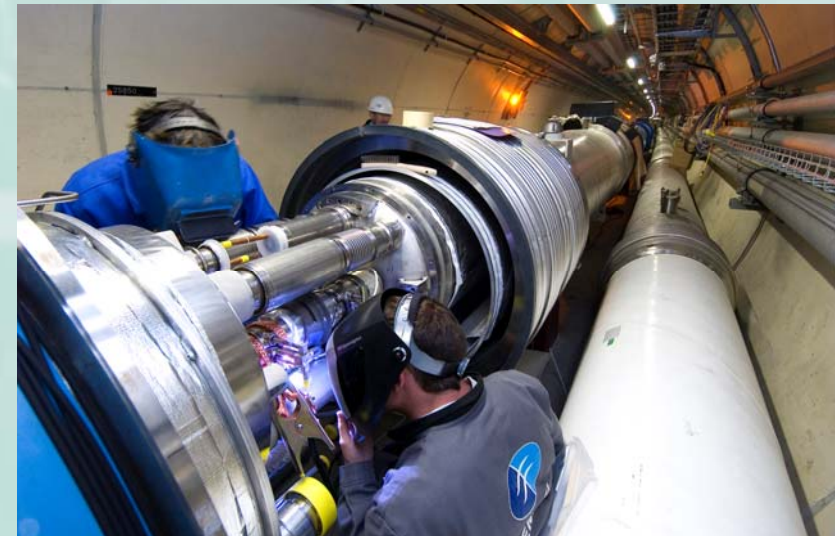
- *ALIGNMENT*

- *THERMAL MOVEMENTS (room temperature)*

• BELLOWS DESIGN

- *Mainly for alignment:*
- => “cardan design”
- *Limited temperature variation*

- *4 large undulations (flexibility)*
- *Rigid spacer*

–For economical reasons:
spacer same material/thickness
=>Undulations needed for rigid.
Nominal height 15mm

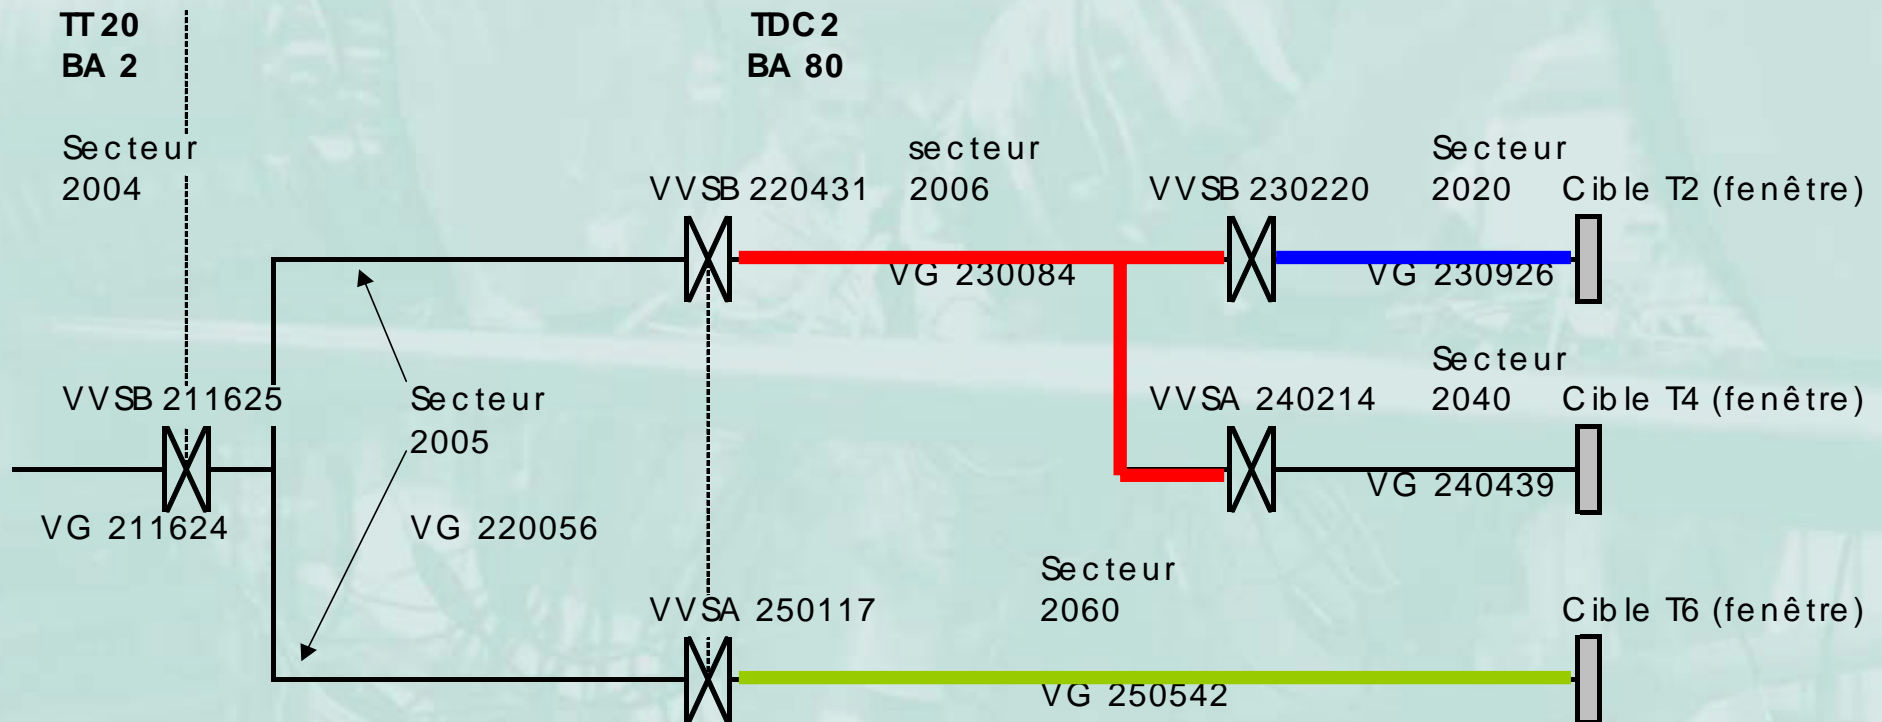
–400 GeV SYNCHROTRON (LHC INJECTOR)

- *FIXED TARGET PHYSICS*
- *HIGH RADIATION AREA (5×10^5 Gray/year)*
- *ALL ST. STEEL CONSTRUCTION (304 L)*
